RESTORATION OF ST. OLAV CHURCH, SERAMPORE, WEST BENGAL

Introduction

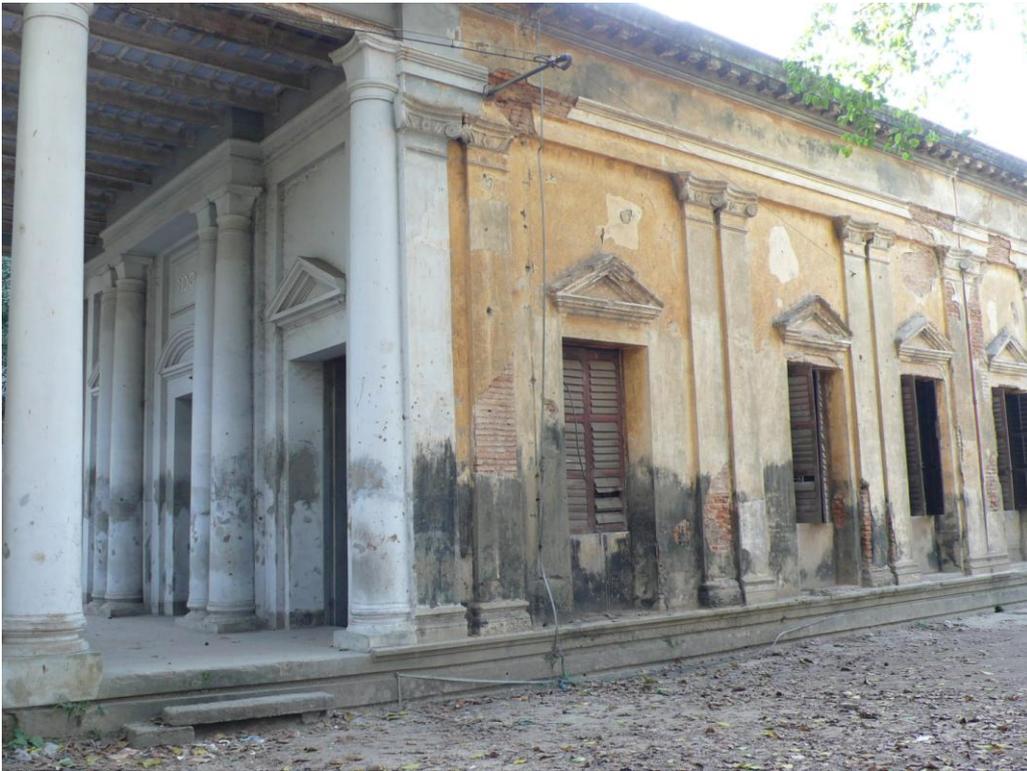
Fig. 3. The application of a uniform ochre color scheme as depicted in 1851 (see fig 2) has continued up to the present, apart from the entrance porch, clock tower and spire, which were painted all over in a grayish white colour at a renovation carried out in the 1990s, leaving no traces of any previous treatment of these parts of the external facades. Photo: Flemming Aalund

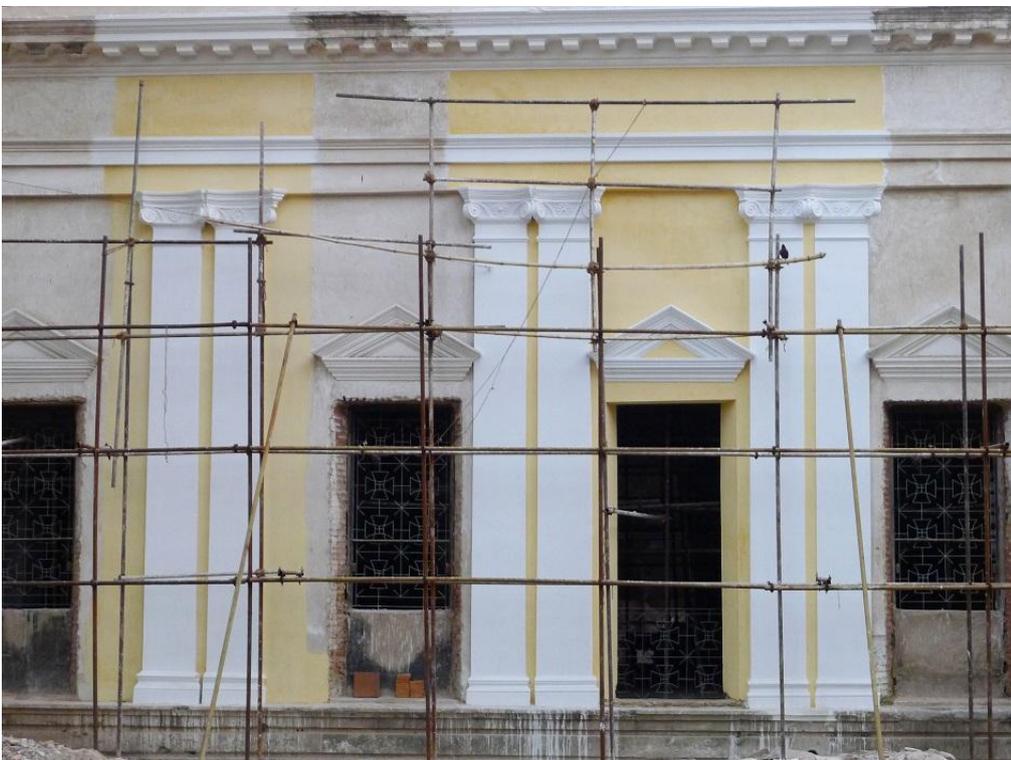
Fig. 4. In conclusion of the paint research it was decided to restore the original colour scheme and treat the external walls with a pale yellow ochre lime wash and accentuate the architectural details by a plain white lime wash. The photo shows the test colors applied to the north façade. Photo: Flemming Aalund.

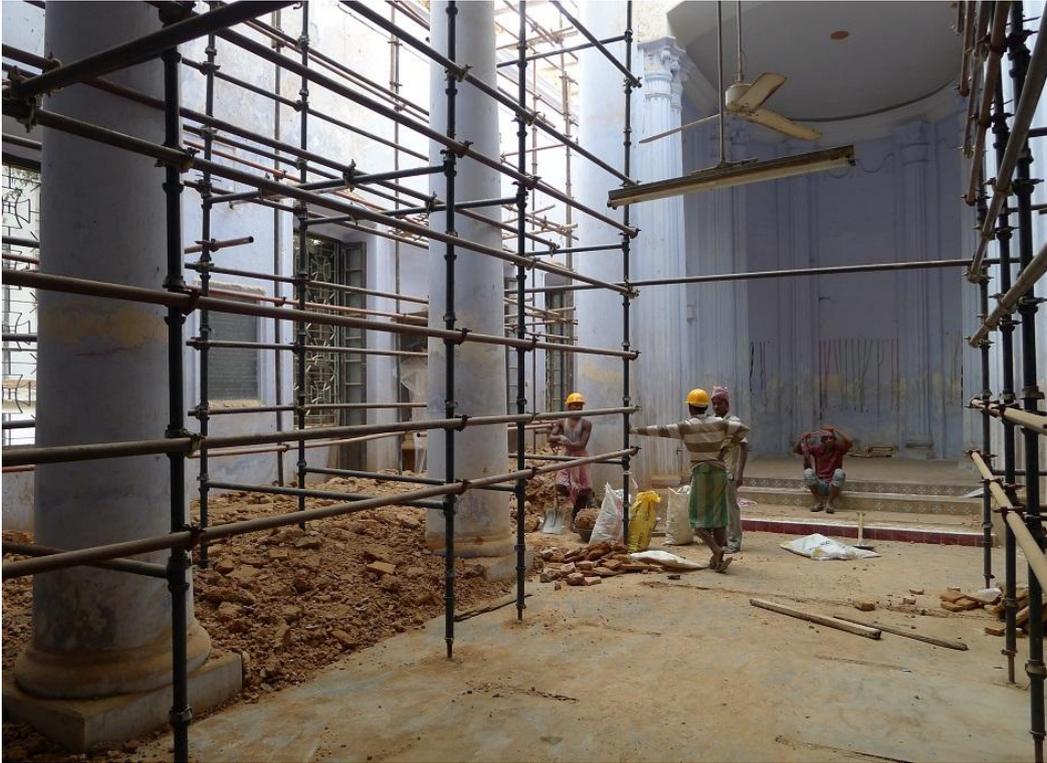
The collapse of a section of the ceiling in front of the apse in 2009 was the ultimate sign of an advanced deterioration of the roof structure. Rain water had been percolating through the concrete screed affecting the supporting wooden beams and *barghas*, making the roofing system extremely vulnerable to collapse.

Fig. 6. For reason of safety steel scaffolding was put up to support the roof beams as the very first intervention before dismantling of the entire roof construction. Photo: Flemming Aalund.

For reason of safety a steel scaffolding was put up to support the roof as the very first intervention, when the restoration was initiated in 2014, and subsequently a detailed condition survey was undertaken to provide documentation and information about the structure, to assess of the building condition and decide on what works need to be undertaken.

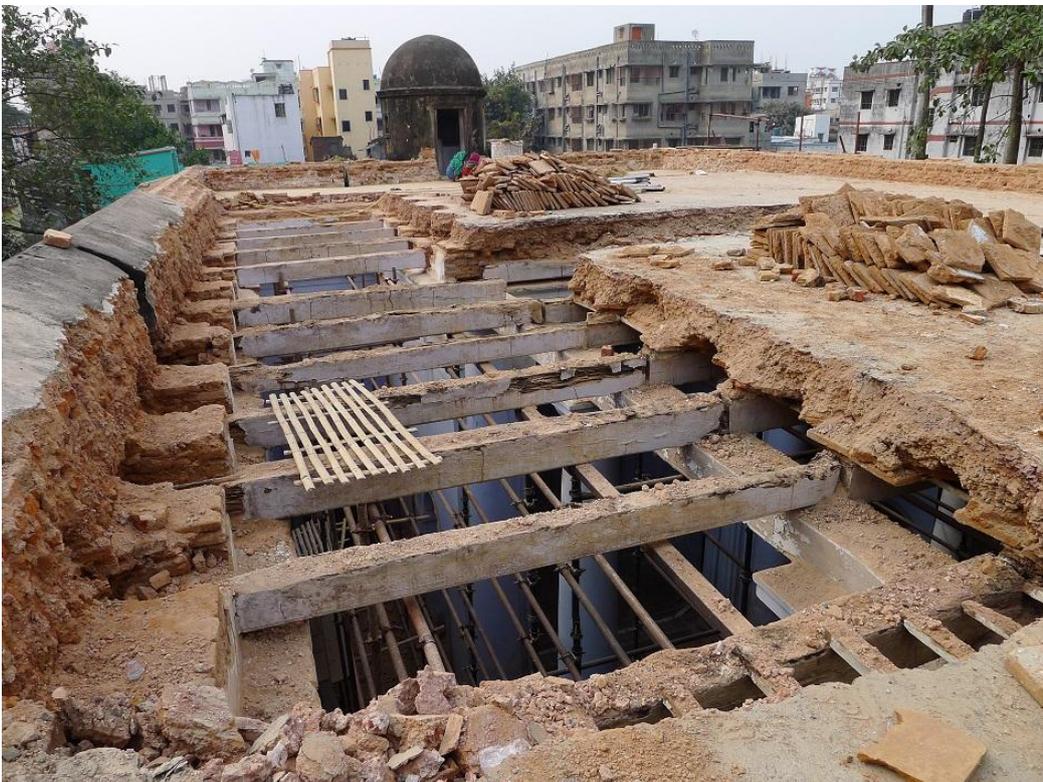
A preliminary assessment by visual inspection carried out in 2008-09 revealed a precarious condition of the roof structure due to termite attack and wooden beams and *barghas* had deteriorated further from moisture migrating down into the construction from cracks in the cement screed.

The investigations made it clear that the problems had accumulated over the years. Embedded into the wall crown to a depth of about half meter the end of the load bearing beams had slowly disintegrated due to termite attack and the damp that permeates the fabric, and some individual hard wood beams had been replaced by iron beams, whereas many more wooden beams were in a precarious condition. Furthermore, it appeared that the part of the roof above the porch had been totally renewed in 1989 and all wooden beams had been changed in favor of steel beams.

Fig. 7. The roof slab has been removed exposing the deteriorated wooden beam spanning the south aisle. The precarious condition of the roof structure is due to termite attack of roof beams and *barghas*, and the deterioration has aggravated further due to water leakage caused by cracks in the concrete screed . Photo: Flemming Aalund.

The terrace roof was constructed according to traditional techniques with a layer of lime concrete on top of two layers of tiles supported by wooden beams and *barghas*. It appeared, however, that an additional layer finished by a cement screed had been added on top of the original roofing system, considerably increasing the total weight of the entire roof. With no expansion joints to compensate for thermal movements, which will be required for rigid materials such as cement mortars, cracks and fissures allowed rain water to percolate into the roof construction gradually, and in combination with the accumulated weight some of the wooden beams had bended and cracked at mid-span, and there was no other way but to replace and renew the entire roof construction including the load bearing structure.

It is an established tradition since long in India to replace hard wood beams with H-steel beams due to the exorbitant high price of well seasoned hard wood in the required dimensions. As an affordable alternative to Burma teak it was therefore decided to use steel beams for the renewal of the roof construction throughout and by welding two standard U-channel sections together it was possible to form built-up box sections of the same dimension as the original wooden beams, but a close look will still reveal that steel has been used to substitute the original wooden beams (refer detail drawings fig. x). This change of construction is more ecological sustainable, considerably reducing the total cost of the restoration, and eliminating risk of attack by termites. For aesthetic reasons the main steel box beams, running the longitudinal direction have been jacketed with wire mesh, plastered with a composite mortar and a groove line drawn along the edges of the beam as a finishing touch to the detail.

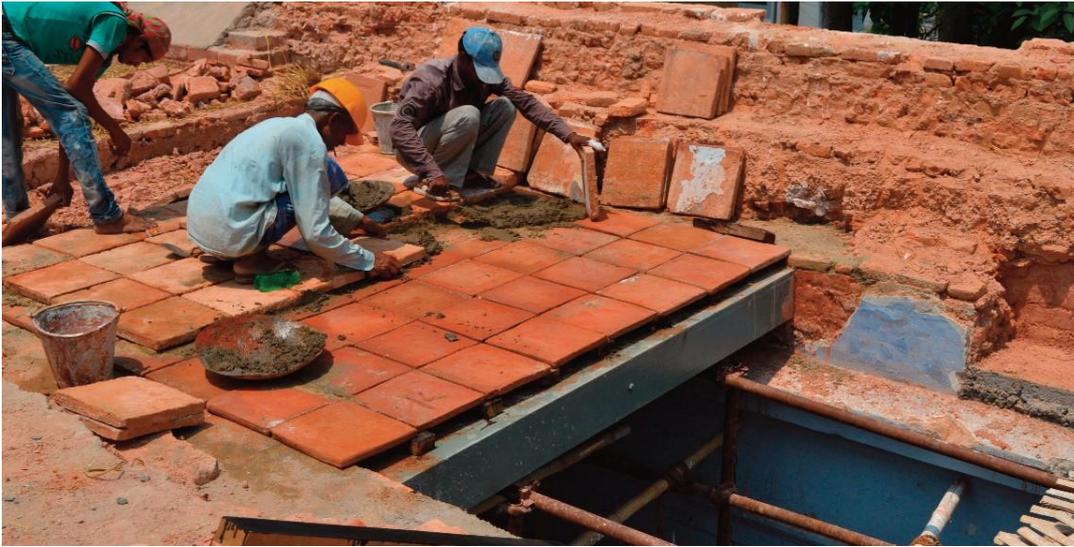
Fig 8 New roof construction Two layers of tiles are placed on top of each other and pointed with lime *surkhi* mortar supported by *borgas* and beams. Photo: Manish Chakraborti.

The traditional method of laying lime concrete terrace roof was revived redoing the construction to the original finish¹³. Spanning the gap between the beams all wood *bargash* were renewed by reuse of sound and solid hard wood recovered from the existing damaged wood beams, which were cut to required size and subsequently the construction is built upwards from the primary framework by two layers of terracotta tiles properly pointed and sealed with lime *surkhi* mortar. The final layer of lime concrete is composed of stone lime with an aggregate of finely crust burned bricks, generally termed brick dust, and crushed over burnt bricks, known as brick bats, in the proportion of 1.5: 2: 7 respectively. Mixed with water at site, beaten and rolled the final mix is laid to an average thickness of about 20 cm with an adequate slope towards the drainage points, where rain water is discharged through outlets in the parapet wall leading to the down pipes.

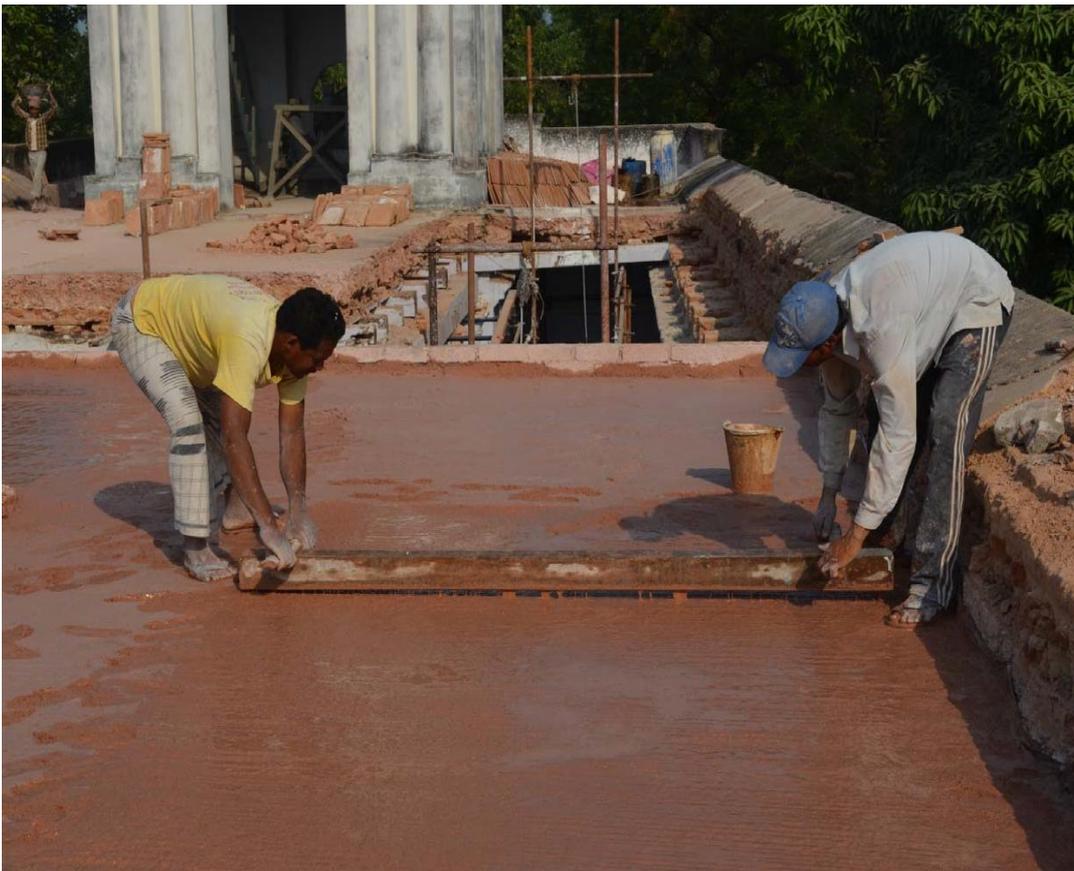
Fig. 9. The roof is being cast with traditional lime concrete in phases starting with the roof above the vestry. The second phase was cast on 21 April 2014 as shown on the photograph. Photo: Manish Chakraborti

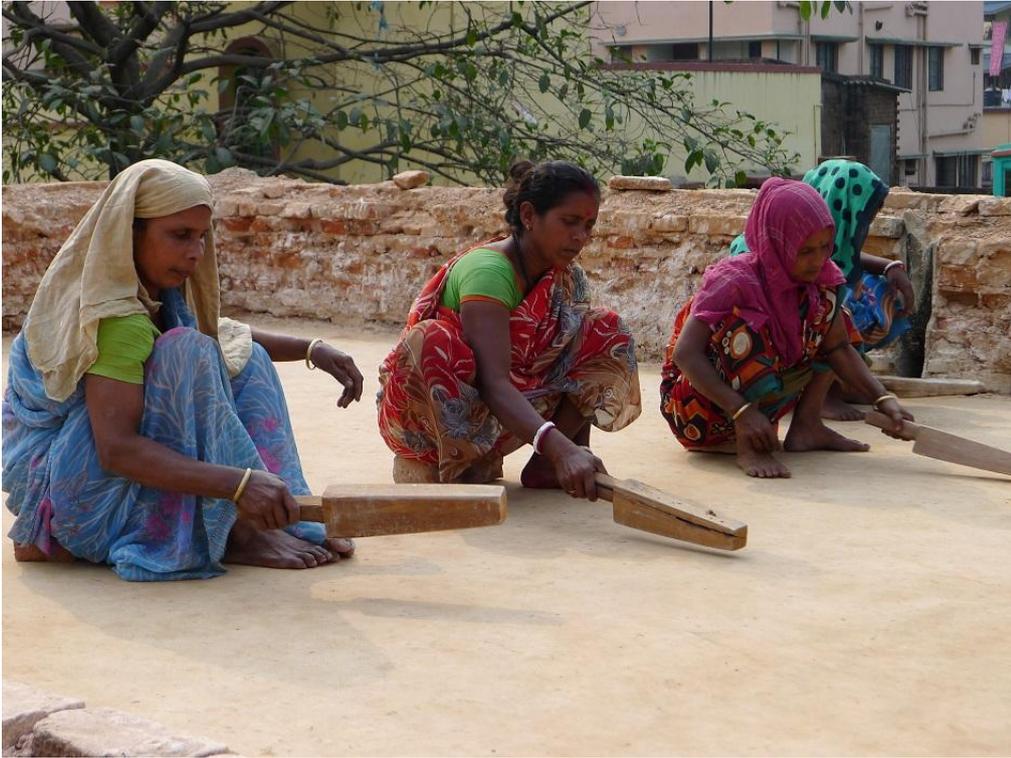
Fig 10 The ramming and compacting of lime concrete is carried out continuously using wooden *thapis*. The workers sit close together, and beat the surface lightly and in rhythm and move forward gradually. The beating will normally have to be carried on for at least seven days until the *thapi* makes no impression on the surface and rebounds readily from it when struck. Photo: Flemming Aalund.

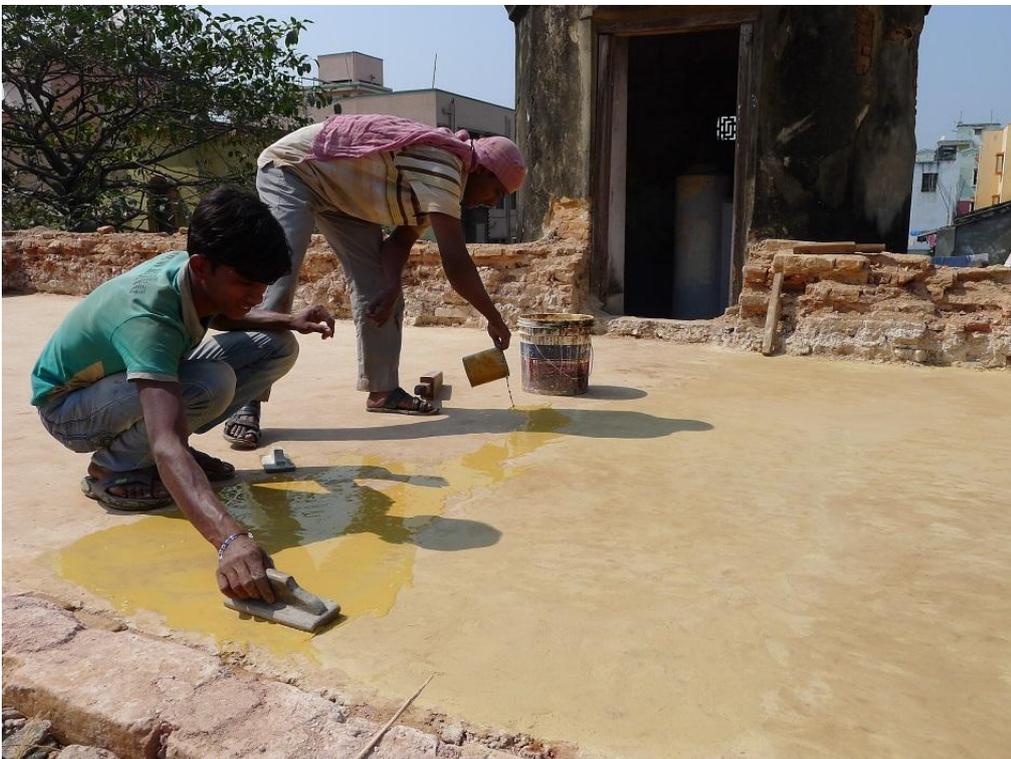
Fig. 11. After laying of the lime concrete, the roof is compacted properly by uniform beating, hardened and finished by adding a slurry of traditional admixture of *khayer and molases*. Photo: Flemming Aalund

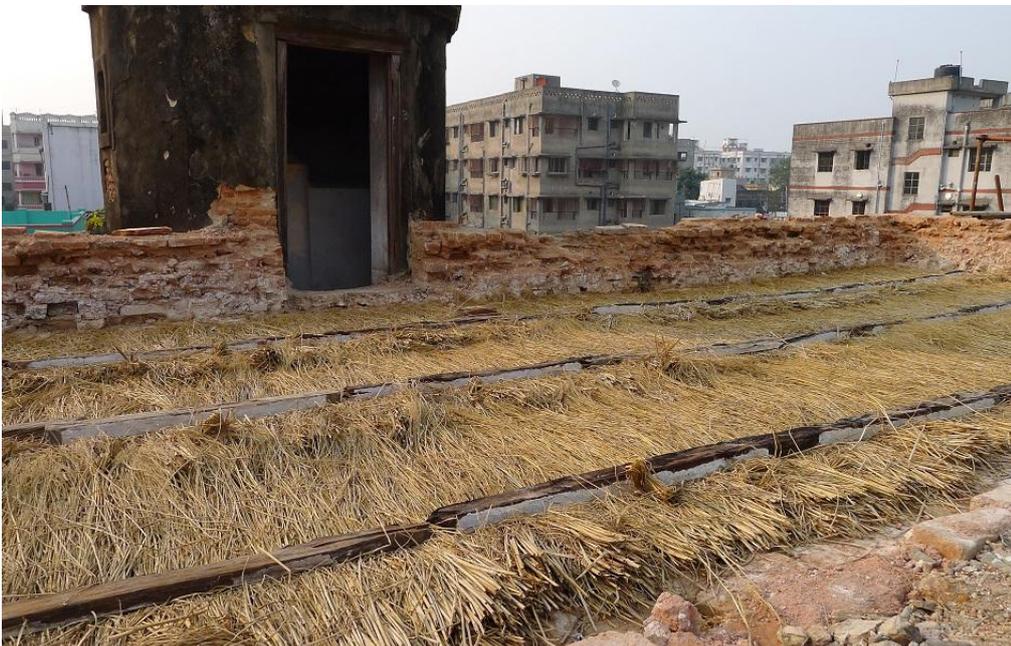
Fig. 13. The roof is left for curing under a cover of moist straw. Photo: Flemming Aalund

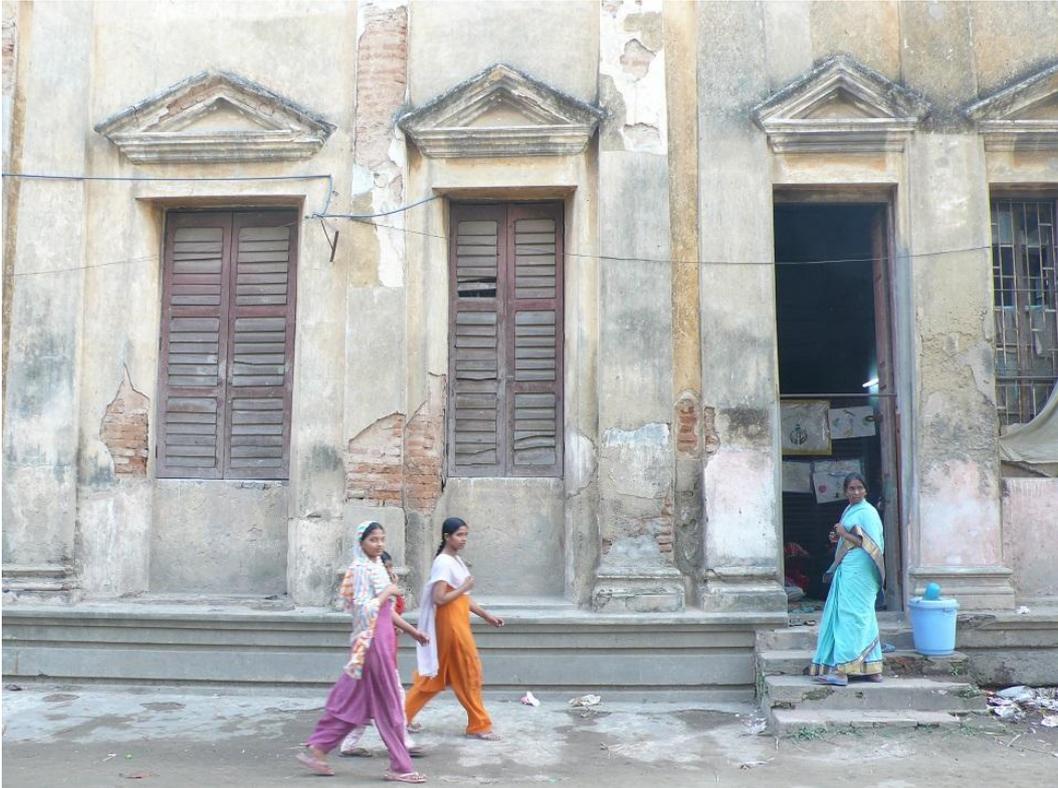
Fig. 14. Part of the northern façade with deteriorated render and the lower section of windows cut away and bricked up. Photo: Flemming Aalund

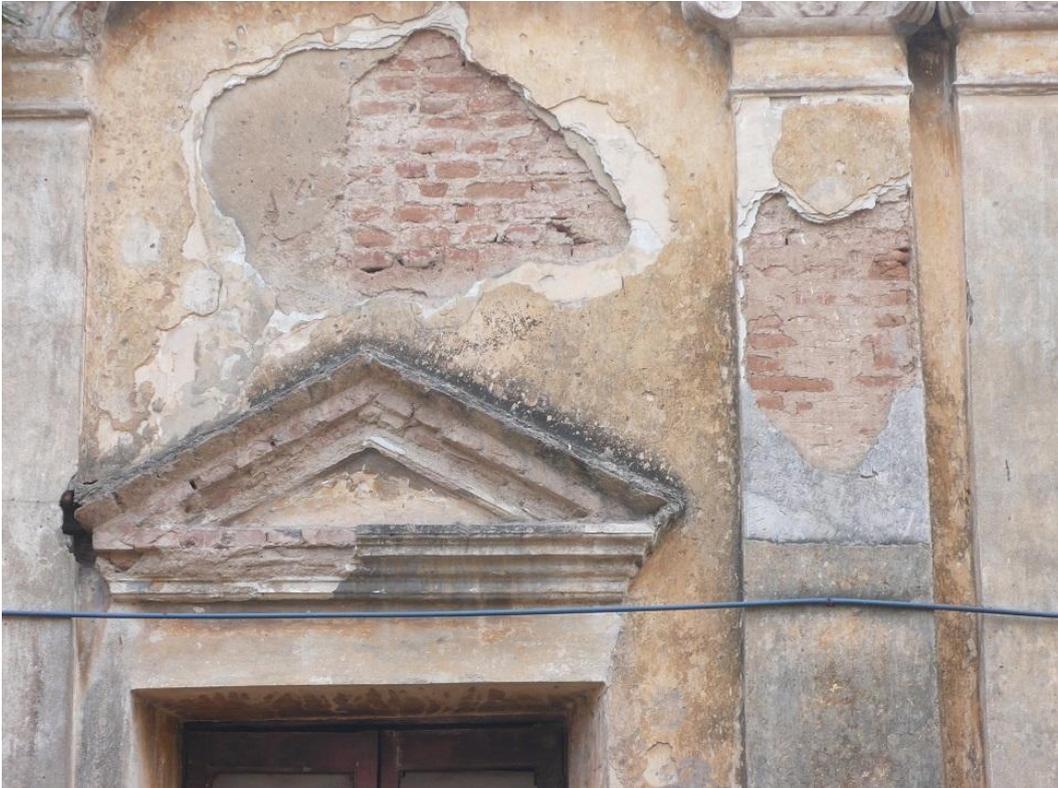
The render at northern facade in particular was deteriorated with large patches of missing plaster and the many layers of original lime plaster and lime wash were easily discerned providing full record of the treatment and different colour schemes in the past, whereas the lower part of the southern facade had been renovated fairly recently by use of cement plaster.

Fig. 15 Detail of the façade with large areas of decomposed render. The many successive layers of plaster and lime wash are clearly visible at the edge where the render is missing. Photo: Flemming Aalund

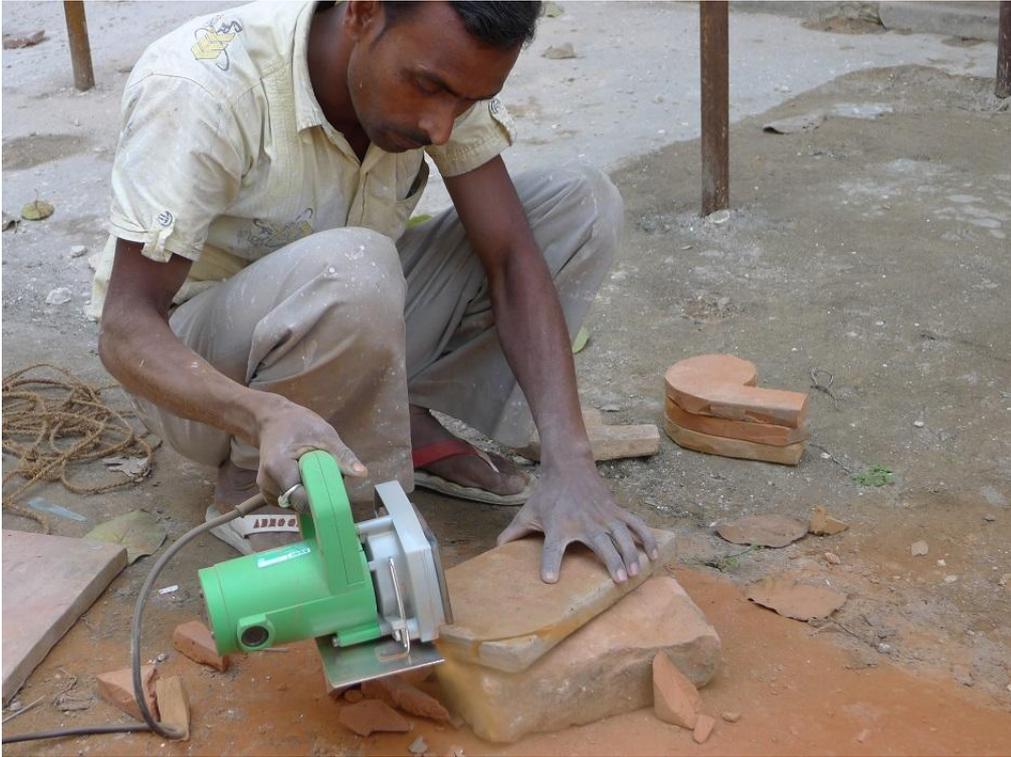
Fig. 16. Cutting of the brick tiles used for remodeling of the capitals above the pilasters. Photo: Flemming Aalund

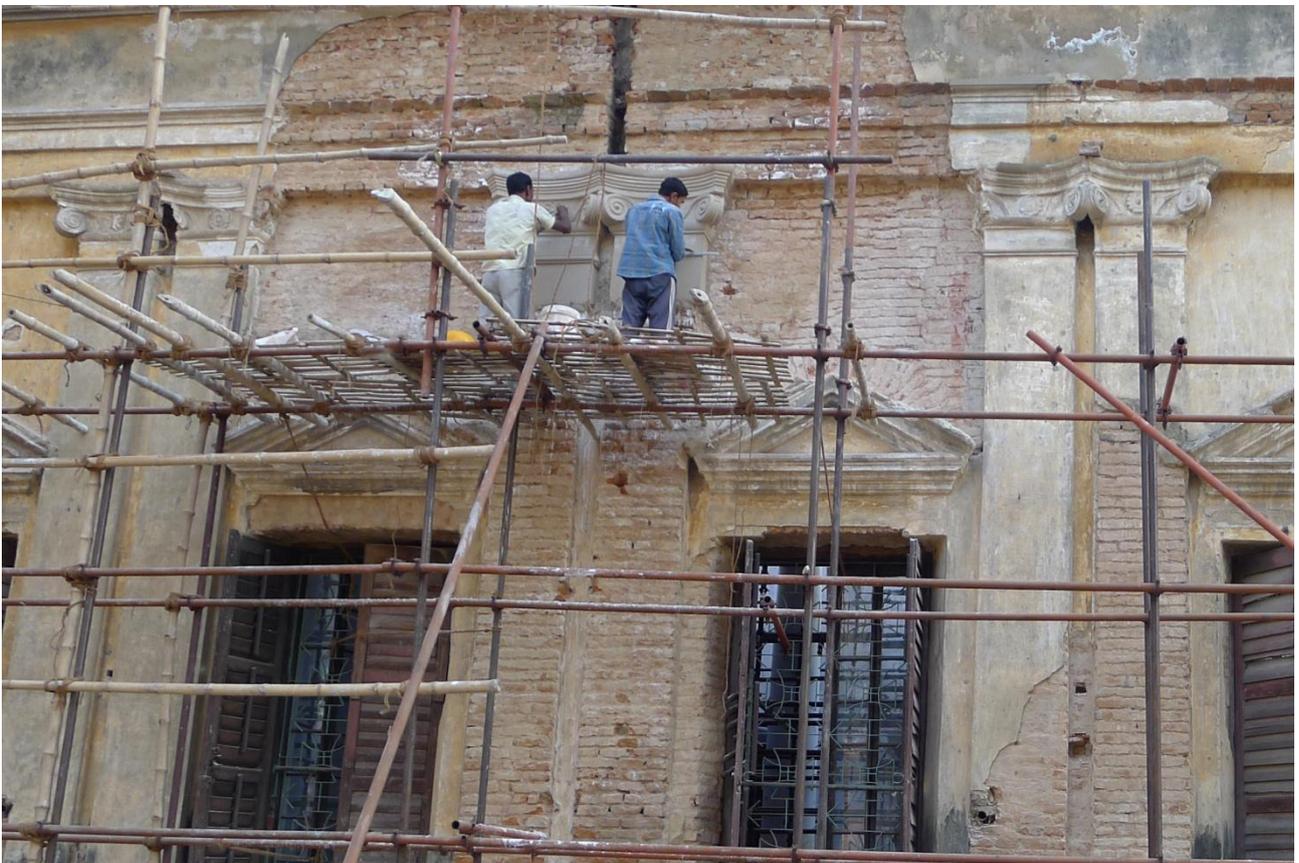
Fig. 17. Remodeling the capitals of the pilasters at the north façade. Photo: Flemming Aalund

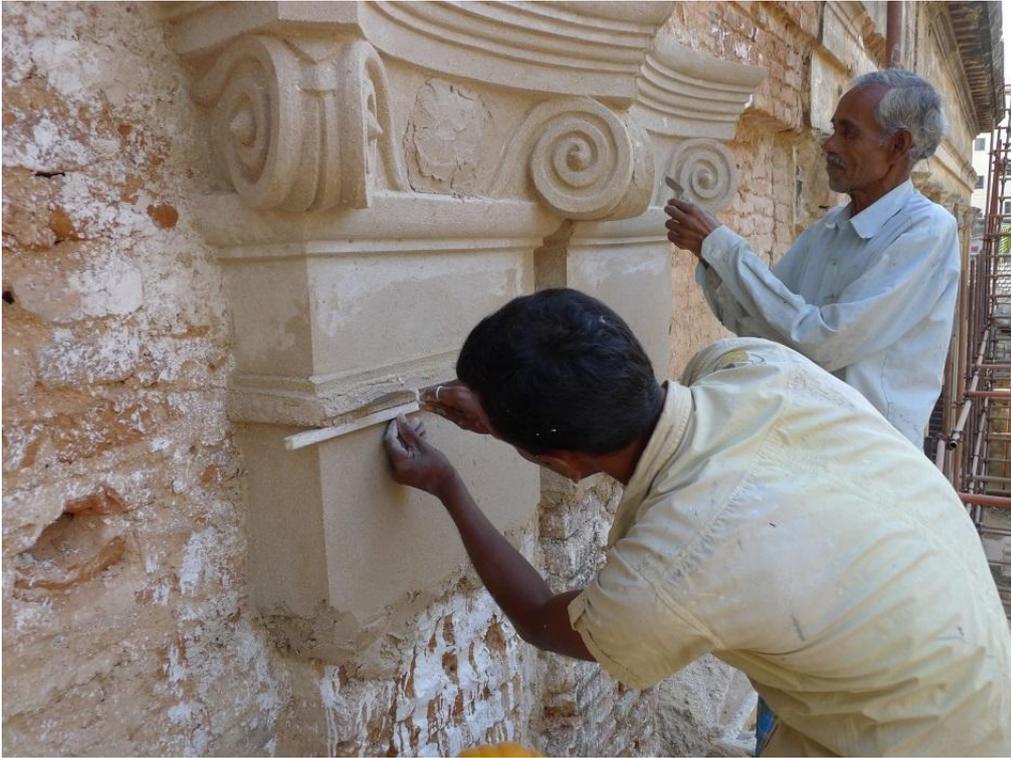
Fig. 18. The architectural decorative features were all in a deteriorated condition and were renewed by masons from Mushidabad, who are well versed in traditional bricklayer's craft. Photo: Flemming Aalund

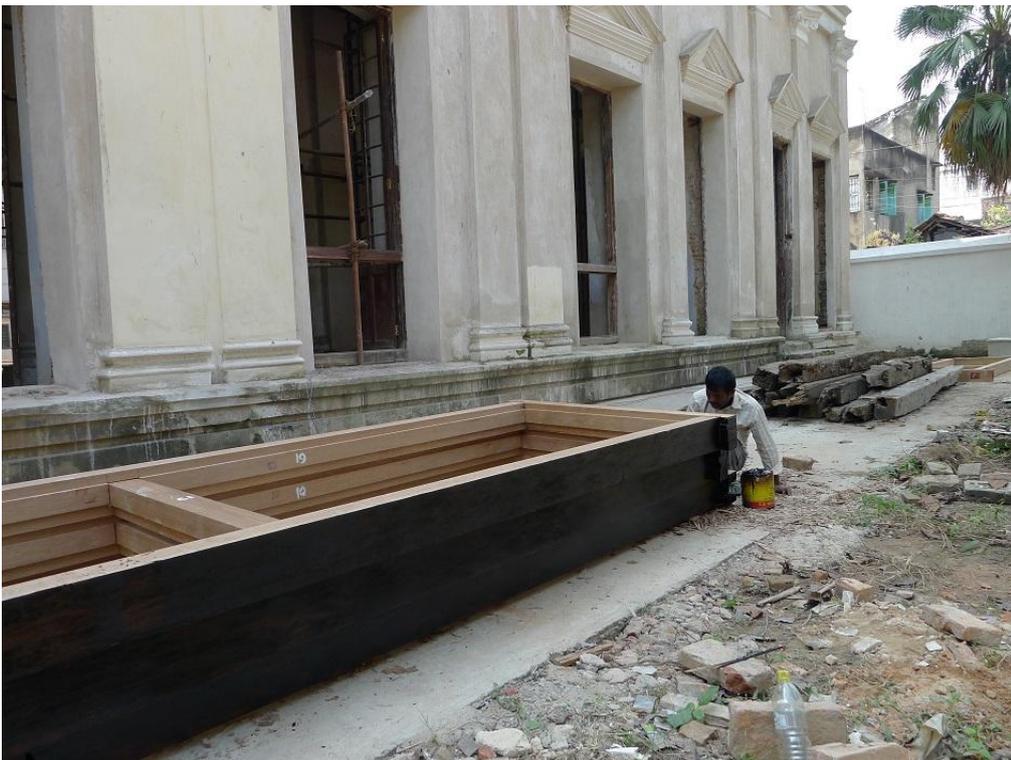
Fig. 19. The new window frames are primed with creosote oil before installment in the façade. Furthermore, the gap between the frame and the masonry is packed with a bitumen and jute fiber filling before sealing of the joint with lime mortar. Being a common construction detail in Denmark this precaution is being introduced to minimize risk for accumulation of dampness and subsequent development of rot in the wooden frame, which has proved to be a great risk in the past. Photo: Flemming Aalund.

Renewed to the original design complete with double louver shutters at top and solid panels at bottom as well as bi-folded glass panel shutters to the inside the frames were reinstated in the facades after proper priming with creosote oil of all the sides of the frames in contact with masonry. Knowing that these parts of the frame are vulnerable to rot caused by the impact of moisture, a building detail commonly used in Denmark was applied, which is commonly used in Denmark by which a caulking joint firmly stuffed with tar impregnated jute fibers are applied before pointing with lime mortar mixed with cattle hair. This measure prevents any moisture in the wall to affect the wood frame and the caulking joint provides flexibility and breathability. The original, as well as the new and reused timber, have been cleaned, scraped, repaired with linseed-oil putty of all defects and sanded, while saving as much of the historic paint as possible before priming and repainting with oil paint in the original reddish brown color.

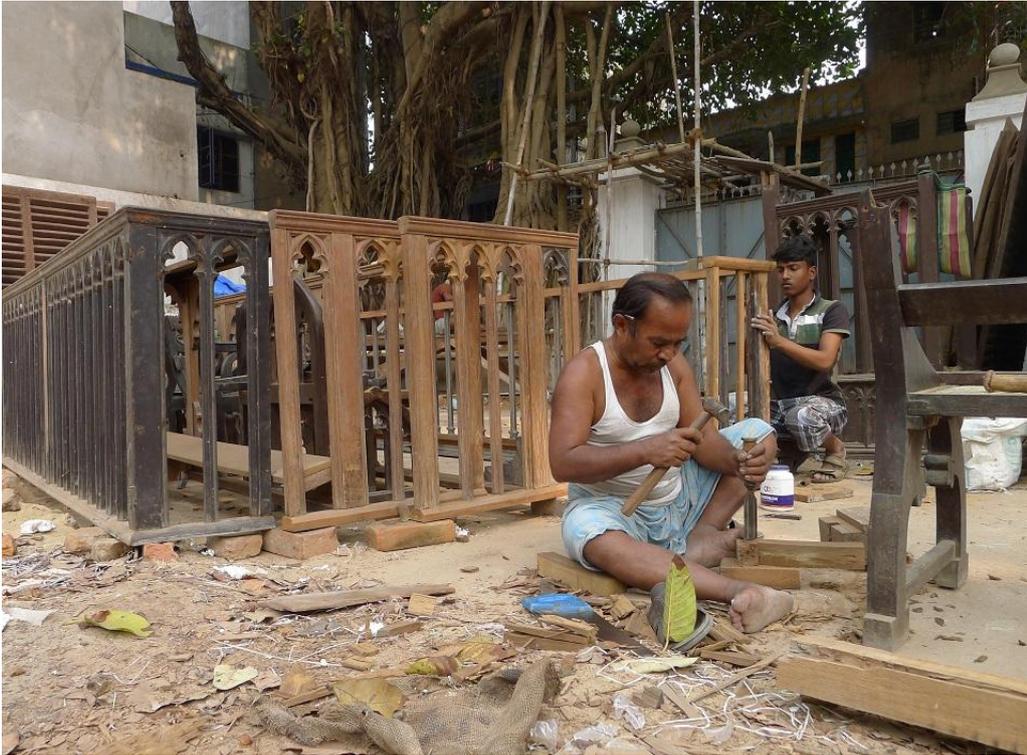
Fig. 22. Repair of the church furniture - pews, pew boxes and chairs, at site before installment in the original position inside the central nave. Photo: Flemming Aalund

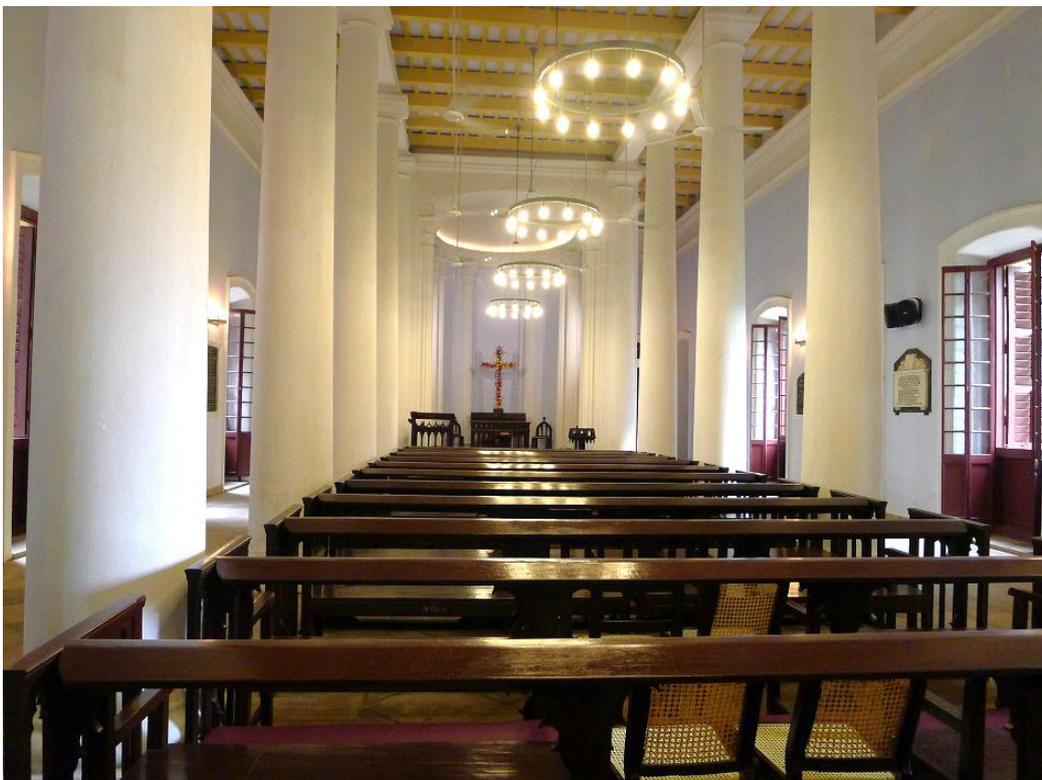
Fig. 23. After safe custody in Serampore College the church furniture have been repaired and put back in the original position. New custom designed circular ring pendant lighting fixtures are hanging from the ceiling of the nave, and half circular lighting fixtures are mounted on the walls of the aisles. Photo: Flemming Aalund.

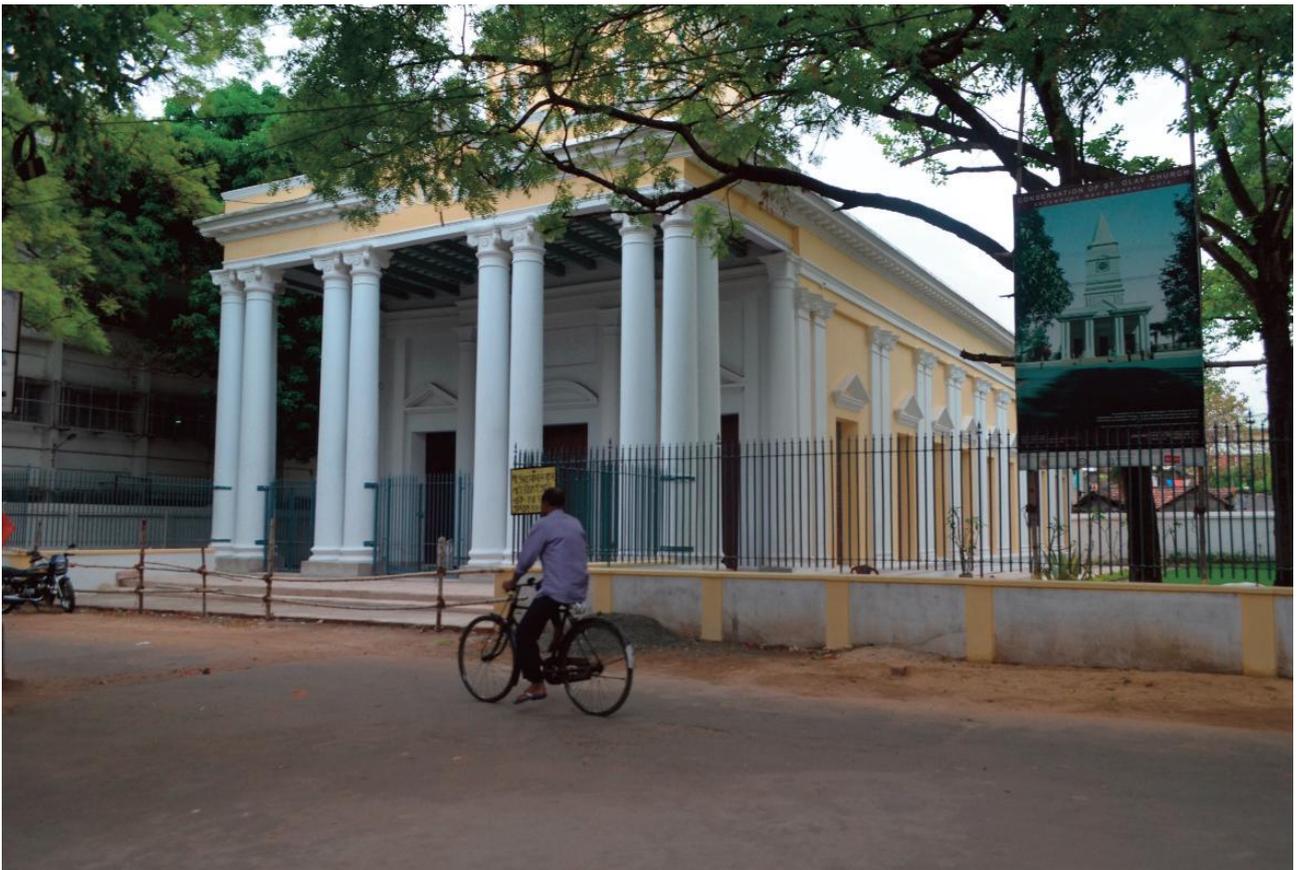
Fig. 25. Front of the restored building with the previous brick wall replaced by a steel railing providing a free view to the church ground. Unfortunately the raised street level has reduced the number of steps leading up to the entrance porch of the church. Photo: Manish Chakraborti

The original gateway flanked by two pillars and the one guard house, which has been maintained, have been restored and the part of the masonry wall facing on towards the street has been replaced by a steel railing that allows a free view of the building and church ground from the street and the town square. The design is inspired from the original iron railing mounted on top of the low masonry plinth as appears from contemporary photographs (see fig. X)
