Die Restaurierung der Madrasa des  
Amīrs Sābiq ad-Dīn Miṭqāl al-Ānūkī und die  
Sanierung des Darb Qirmiz in Kairo

#### E. PROPOSAL FOR THE RESTORATION AND REHABILITATION OF WĀKĀLAT BĀZAR'Ā

(FLEMMING AALUND)<sup>1</sup>

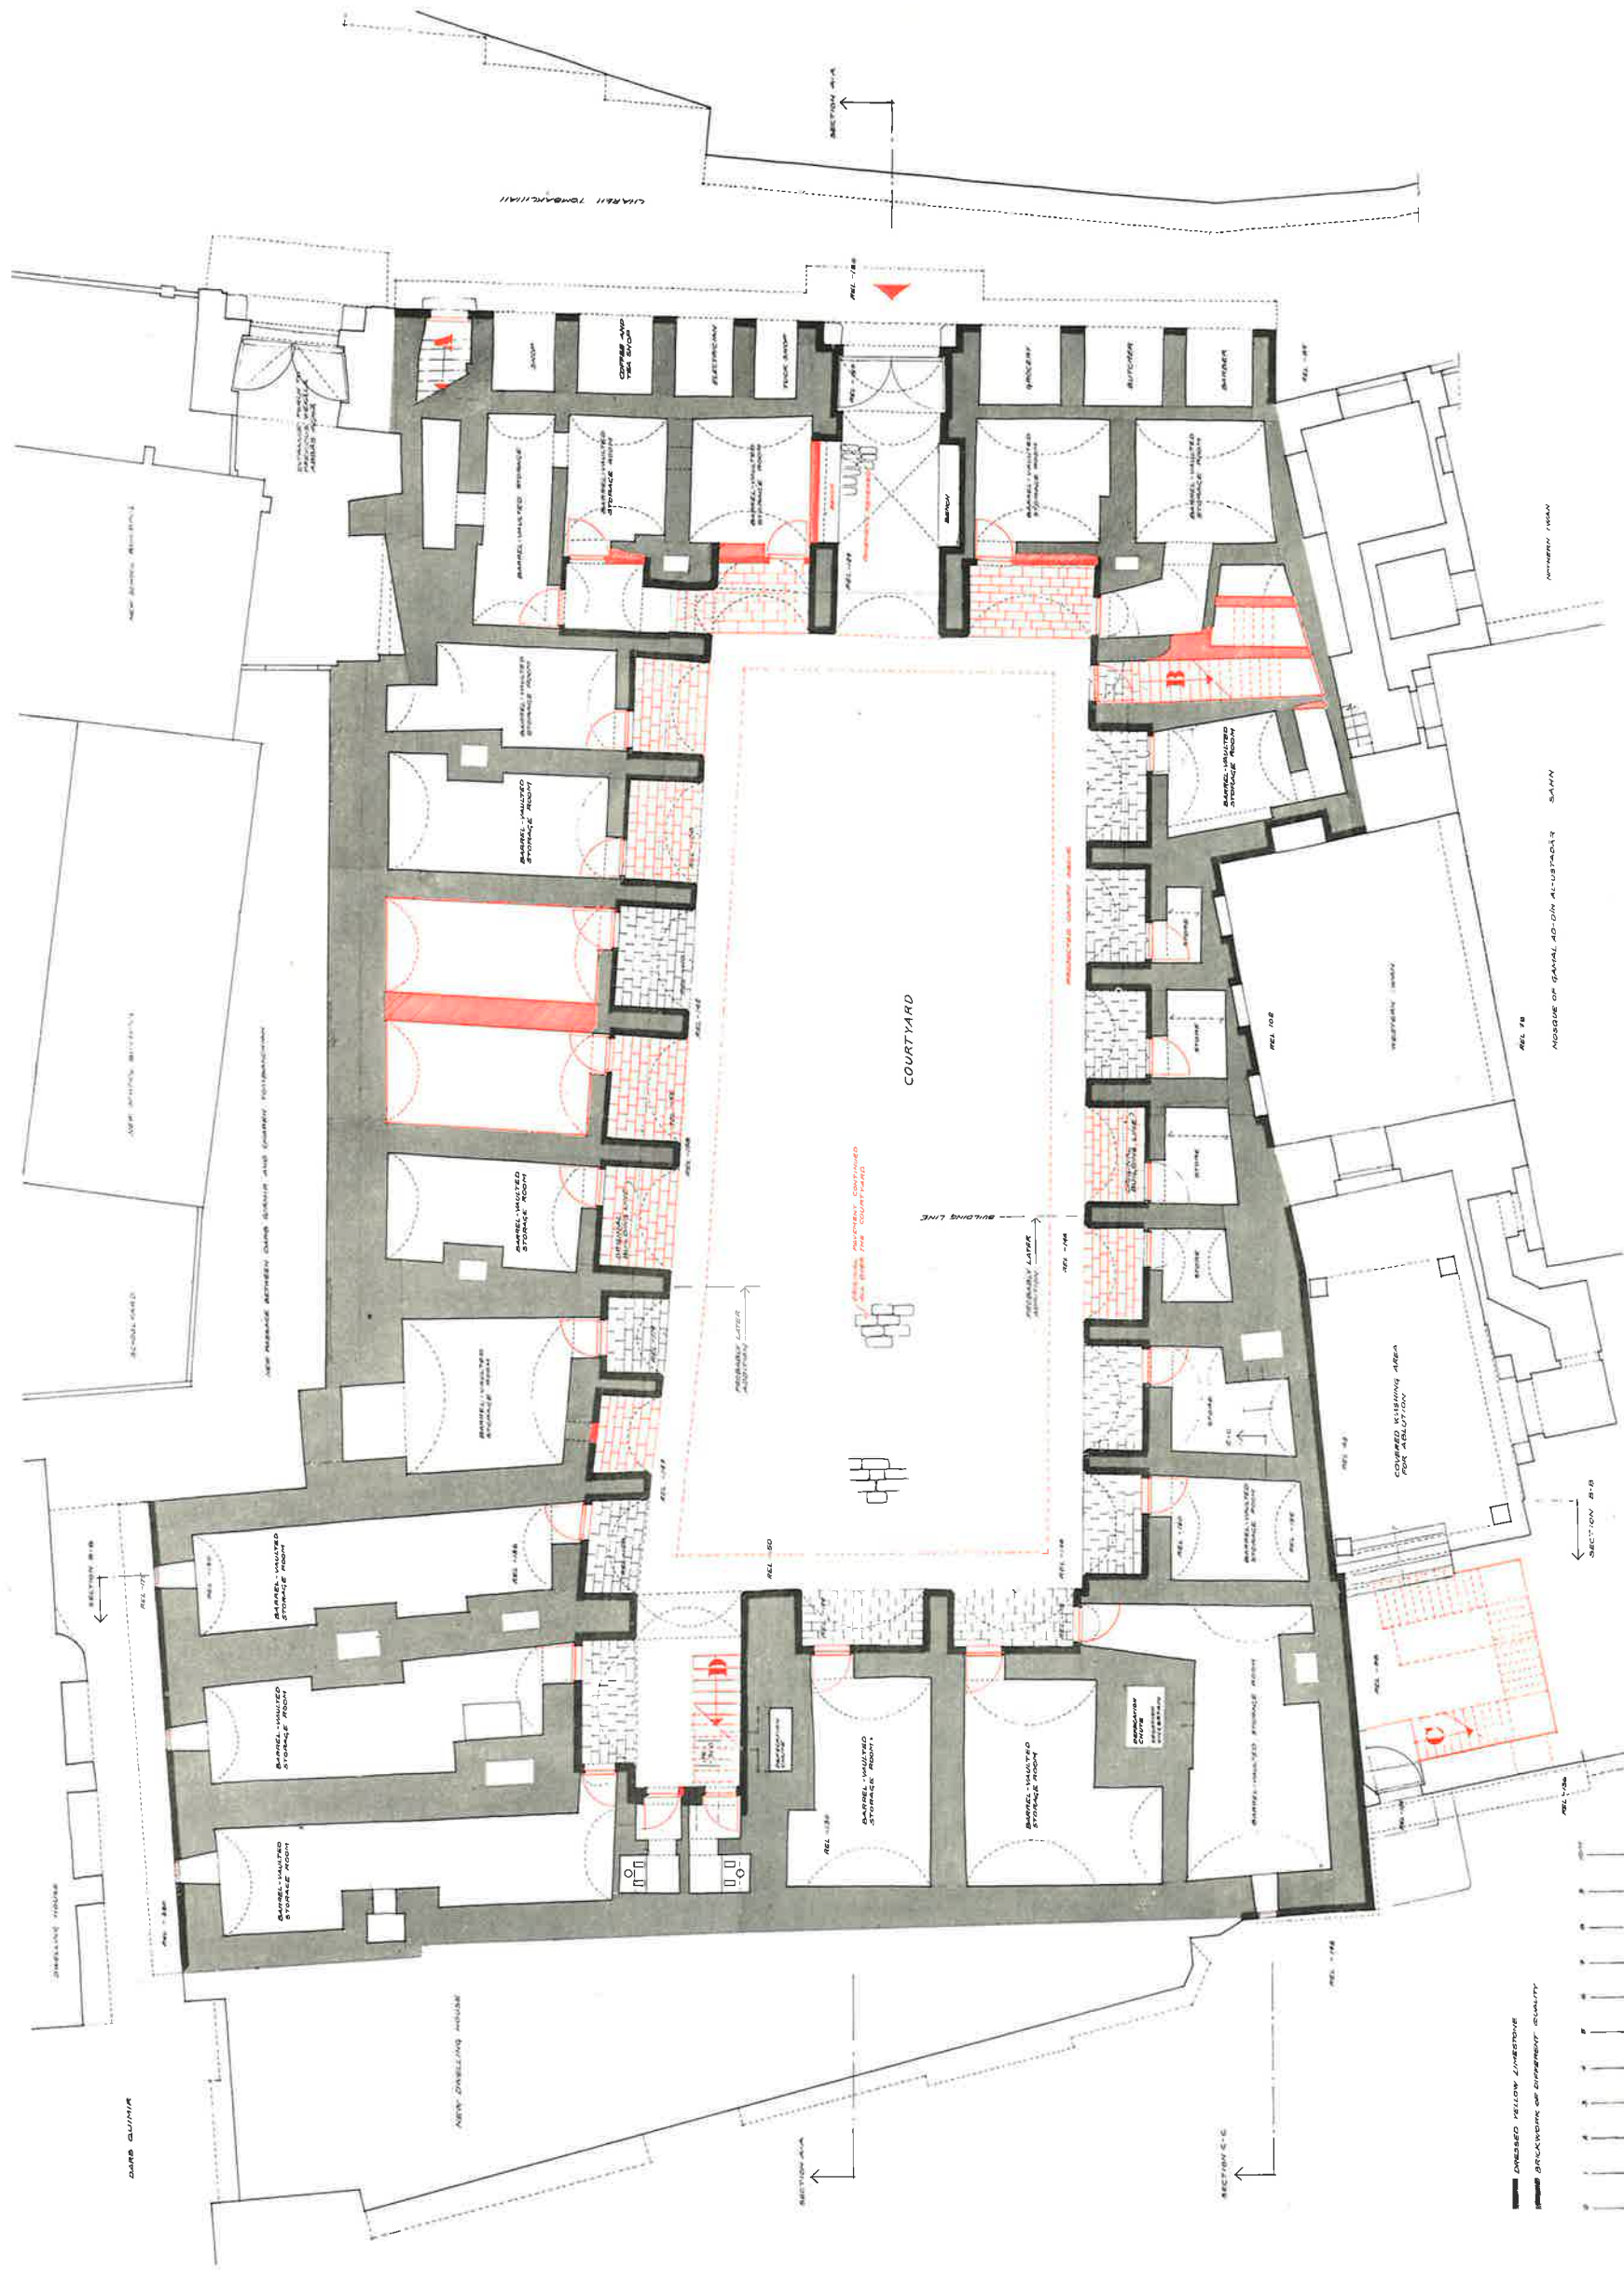
Abb. 49 Wakalat Bazar'a, plan of ground floor, proposal for restoration; scale 1:200 (Flemming Aalund)

building (Abb. 49, 51, 53, 55, 57). The extent of original brickwork and walls that must be pulled down because of their condition can only be decided on the spot during actual restoration work. But the basic architectural measures should already be planned in advance: namely the aesthetic appearance of the exterior, the necessary improvement of accessibility to the first and second floors the renovation of the middle part of the western wing which has totally collapsed (Abb. 52, 54, 56), and finally the western facade, which is now exposed and open to view after the demolition of the adjacent Wakālat 'Abbās Āgā c. 1965 for the benefit of a new school building (Abb. 64; Taf. 42b).

and a passage should be opened along the western facade linking the *wakāla* to the small alley leading to the Madrasa of Amīr Miṭqāl, i.e. the north-eastern extension of Darb Qirmiz (compare Abb. 48 with Abb. 49).

To-day only the staircase (A) leading from the north-western corner of the street facade to the upper floors is still functioning; in addition the access to the living-units should be facilitated by further staircases (Abb. 49, 51, 53):

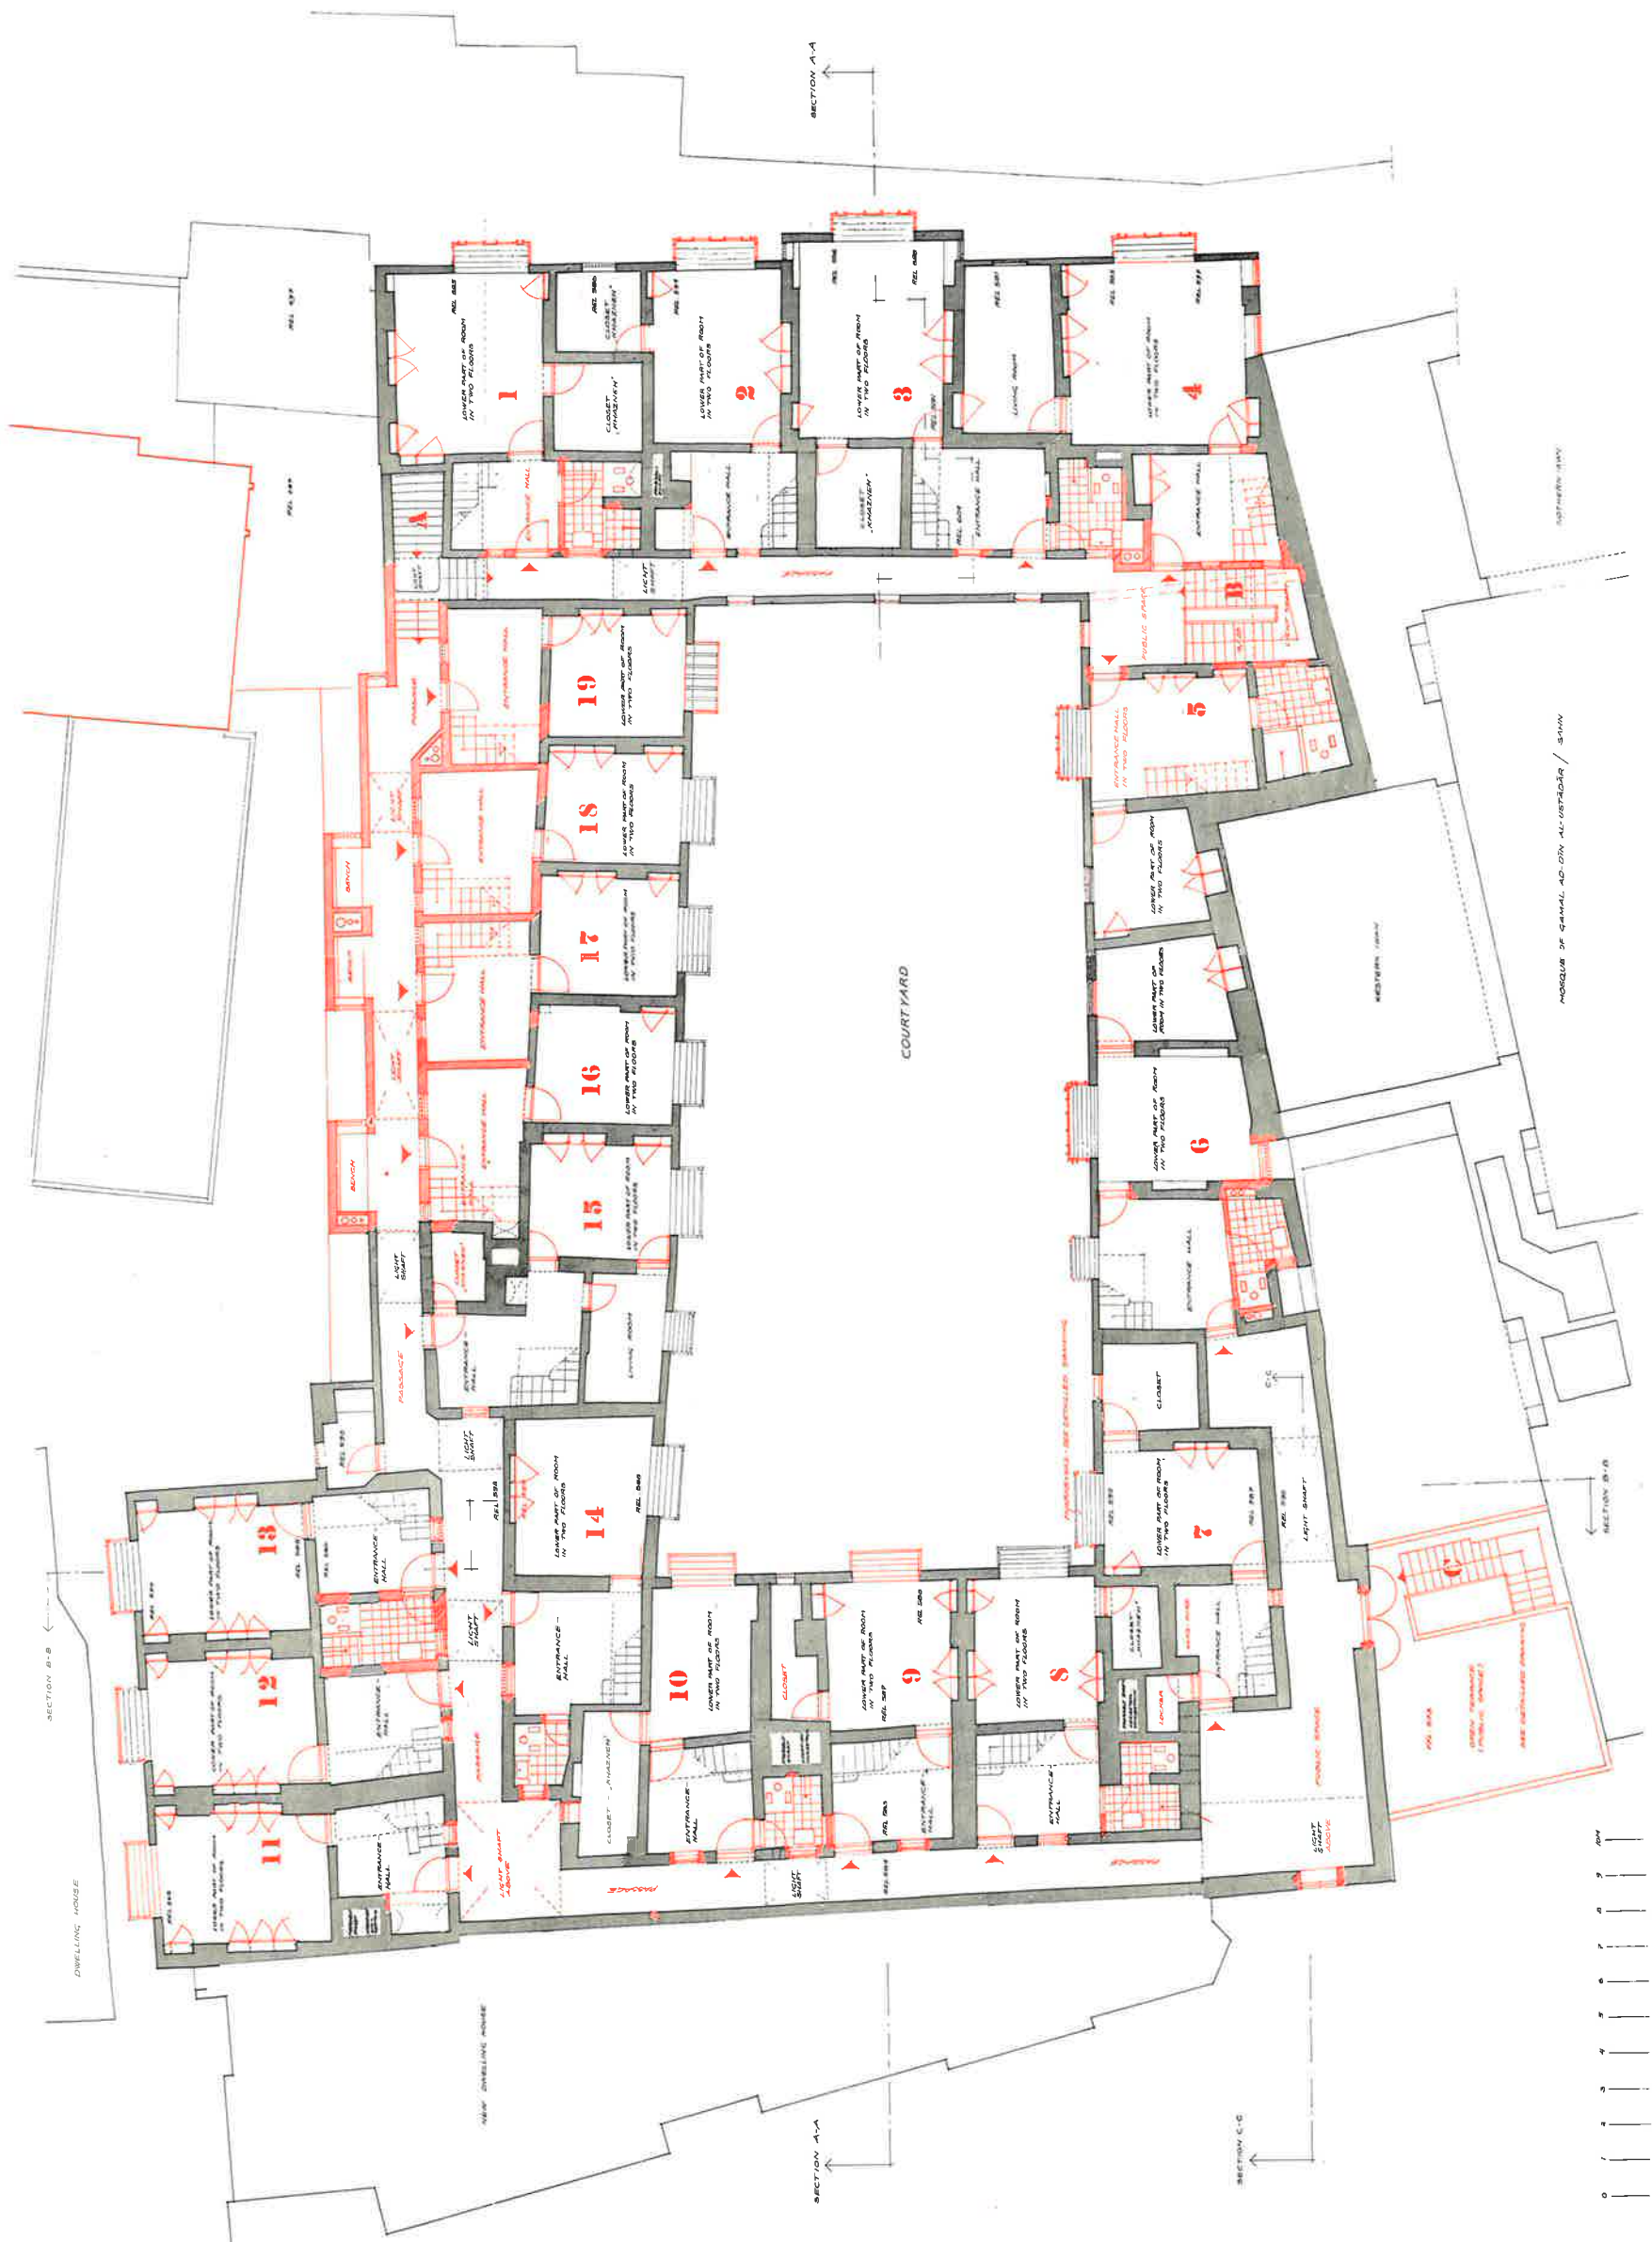
Abb. 53 Wakalat Bazar'a, plan of second floor, proposal for restoration; scale 1:200 (Flemming Aalund)

<sup>15</sup> The proposed alterations have been marked on plans of the different floors (Abb. 53, 55, 57); in addition the three floors of each of the 19 flats have been drawn separately; see Abb. 59–63 (precisely only the drawings of the flat no. 1 occupying the northern corner has been published: [op. cit. note 1] 1977, fig. on p. 28).

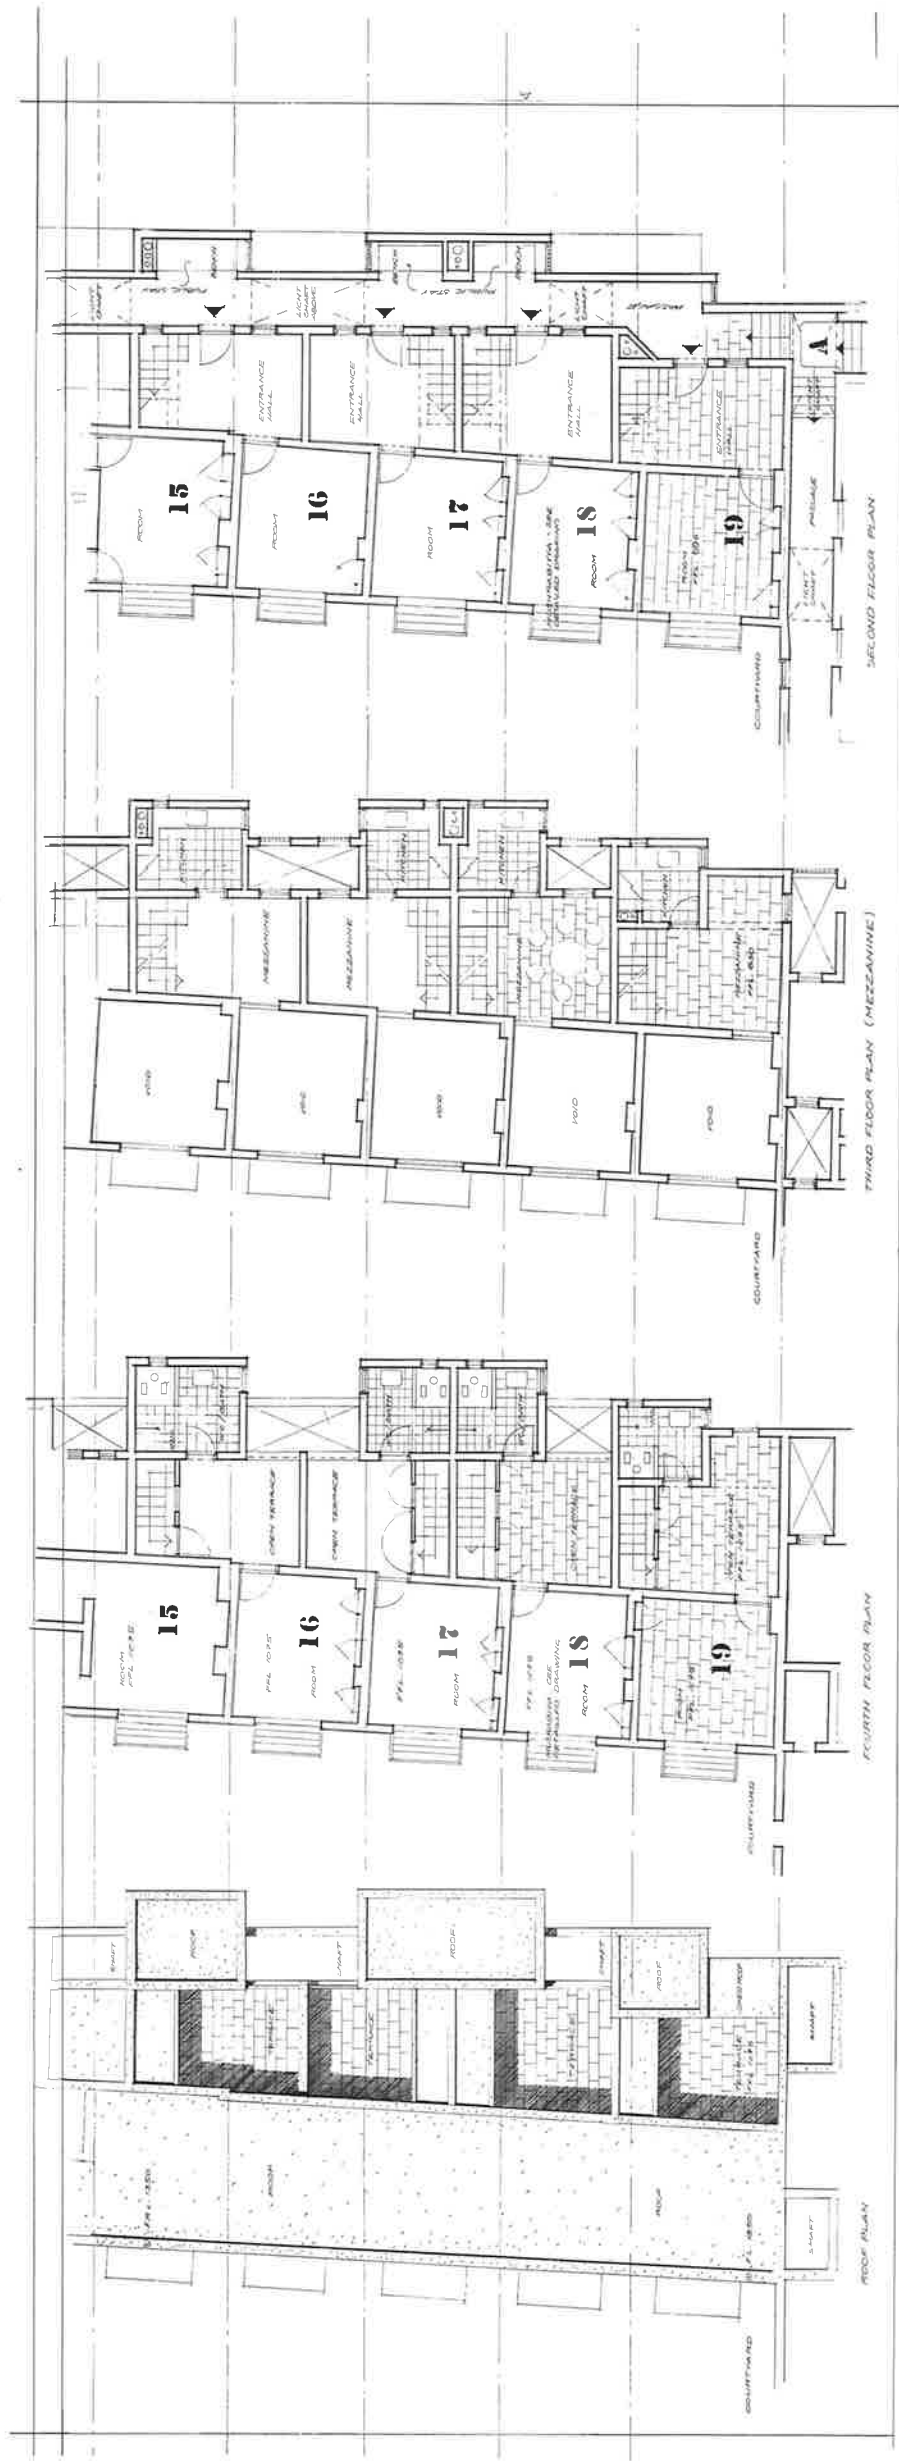
Abb. 59 Wakālat Bāzar'a, plans of flats nos. 15–19 in four levels, proposal for restoration; scale 1 : 200 (Flemming Aalund)

By having the toilet and the kitchen facilities concentrated above each other in a „core“ projecting 0,50m from the original facade (Abb. 59), it will be possible to reach a room depth of 2,40m, which will be a reasonable space for these functions. Thus also in the entrance floor, i.e. the second floor of the building, the corridor will have more space, that can serve as sitting places for the inhabitants. As for the lower part of the facade it will be one line with the still existing parts of the basement of the former Wakālat ‘Abbās Āgā (Abb. 65).

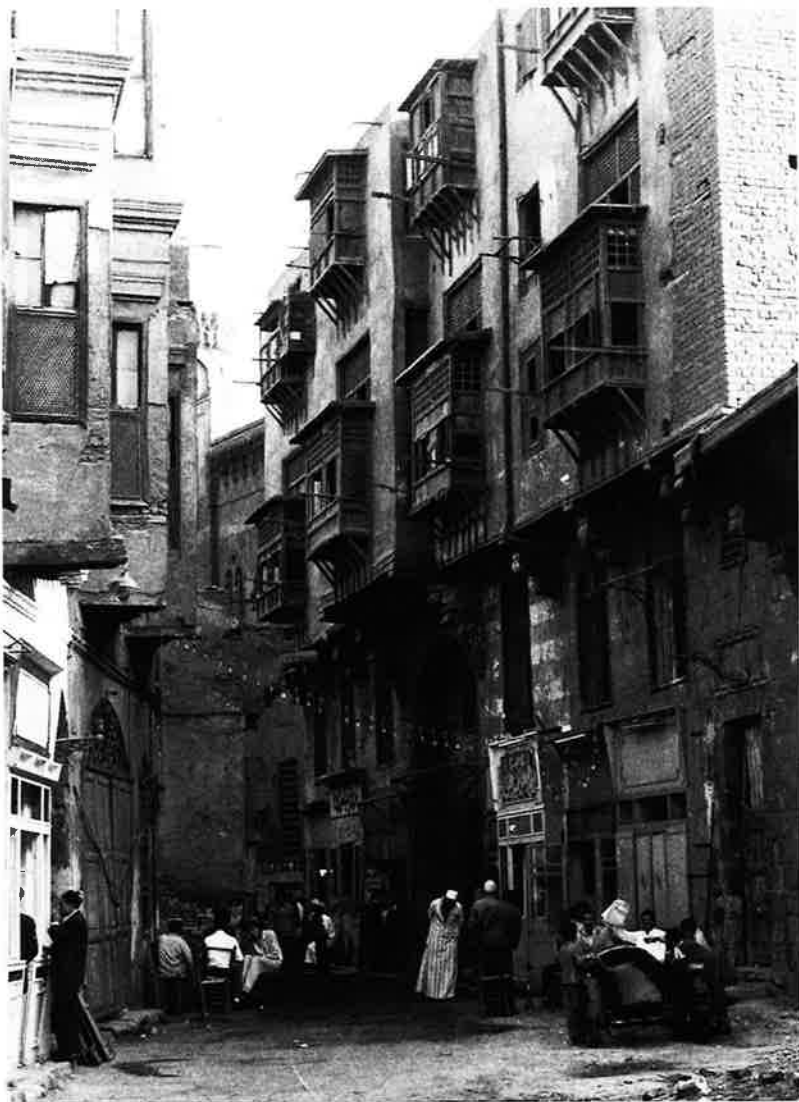
a Wakalat Bazar<sup>a</sup>, Nordfassade

The most intact part is the main facade at the northern side towards Šārī' at-Tumbakšīya (Abb. 47; Taf. 42a), which – together with the adjacent gateway of the Wakālat 'Abbās Āgā (1106/1694–95)<sup>8</sup>, the Madrasa of Ġamāl ad-Dīn Yūsuf al-Ustādār (built from 810/1407 to 811/1408)<sup>9</sup> and the Wakālat Du l-Fiḡār (1084/1673–74)<sup>10</sup> – composes a fine ensemble of the regional Islamic building tradition. The typical corbelled upper storeys of this building together with the narrow streets are means of adaption to the climate to protect against the heat during the hot summer time. The windows were originally filled with wooden lattice screens in turned wood-work, at the same time allowing free air ventilation and softening the glare without dazzling the eyes. Each main living room has a projected window as a prominent feature, in Arabic called *mašrabīya*, which signifies „a place for drinking“, where the drinking water was cooled by evaporation from porous earthen bottles exposed to the air current. The projecting *mašrabīyas* at the same time create a feeling of more interior space and allow a free view down the narrow streets<sup>11</sup>.

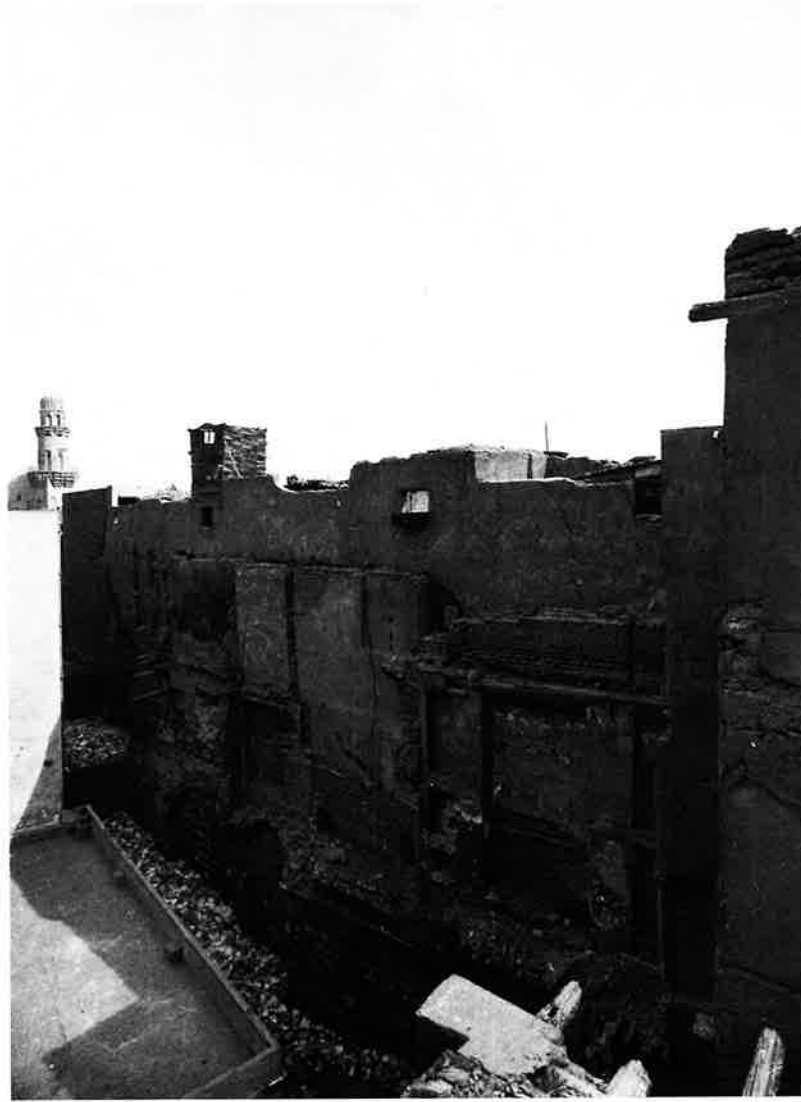
b Wakalat Bazar<sup>a</sup>, Westseite

- b. All facades to the exterior (Taf. 41 b, 42 a, 43 b) should be preserved in their present state – except the recently exposed part of the western side (Taf. 42 b) which will be dealt with separately (see below pp. 138 f.).
  - All brick walls will have to be plastered.
  - New doors reconstructed according to their original form should be put in.
  - All missing *mašrabīyas* should be restored or made anew, as well as the decorated wooden canopy between the ground and the first floor.
  - All the window openings should be filled out with new lattice screens or roundcarved wood-work or closed with shutters, as it is the case in front of the *mašrabīyas*. New frames with glass should be added in rooms for living purposes.
  - New combined benches and balustrades should be inserted between the pillars of the arcades overlooking the courtyard on the first floor.

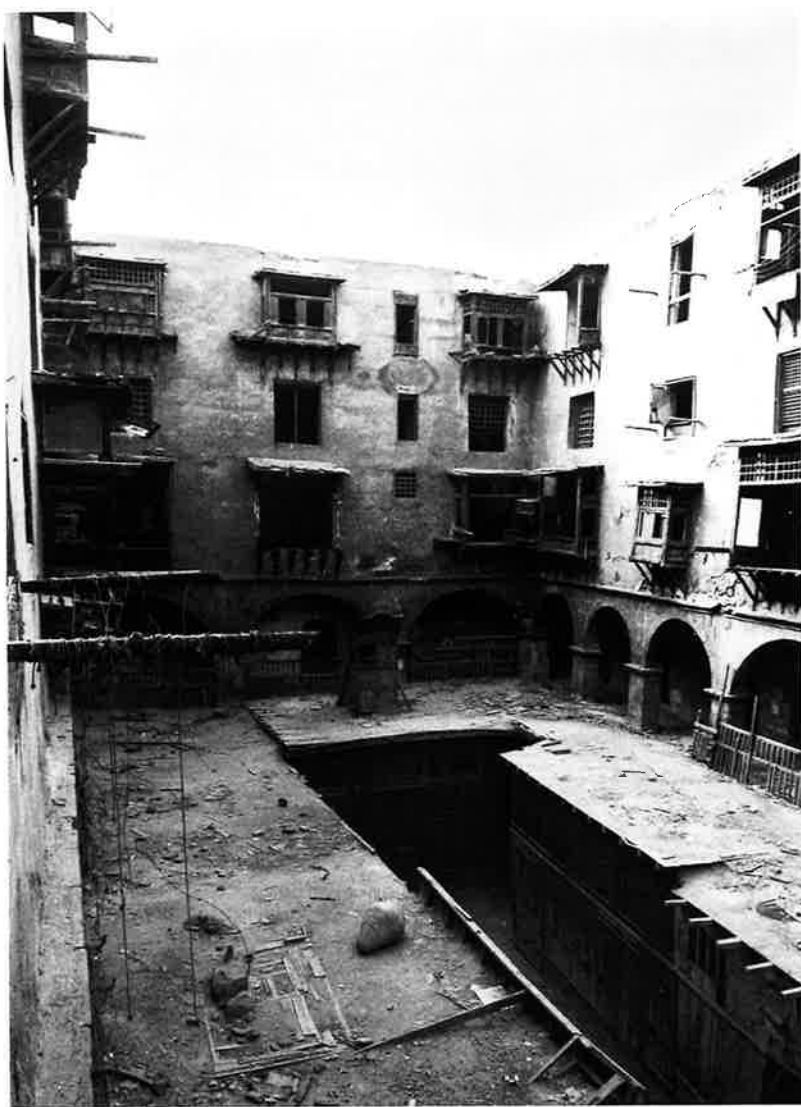
c Wakalat Bazar<sup>a</sup>, Innenhof – Blick nach Süden

This *wākāla* covering an area of about 46 × 34 m faces a rectangular courtyard with two lower storey in stone, and three upper storey in plastered masonry (Taf. 42c), each floorage about 1000 m<sup>2</sup> (Abb. 48, 50, 52, 54, 56). On its outer limits the plan is

- The temporary buildings of wood in the courtyard (Taf. 42c) should be removed.
- The courtyard and all niches in front of the storage rooms on the ground floor level should have a new pavement (Abb. 49).
- The blocked entrance gate to the area formerly occupied by the Wakālat 'Abbās Āgā should be opened,
