RESTORATION OF ST. OLAV CHURCH, SERAMPORE, WEST BENGAL

Introduction

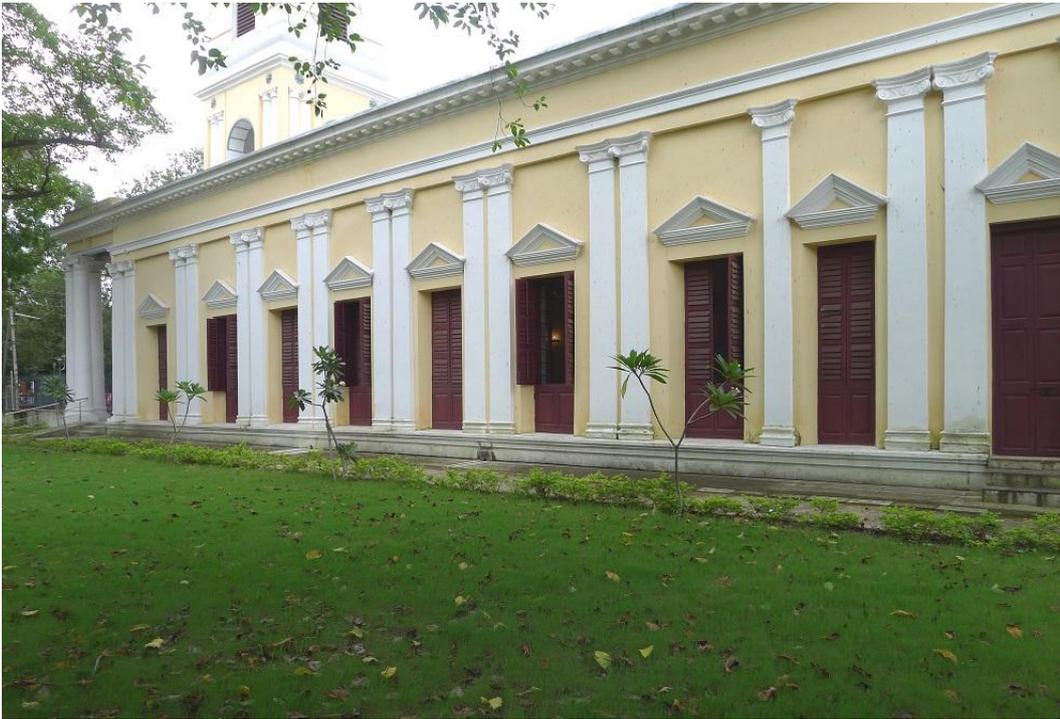
Fig. 5. Appearance of the south façade after completion of final lime wash of the façade and painting of all woodwork. Photo: Flemming Aaund

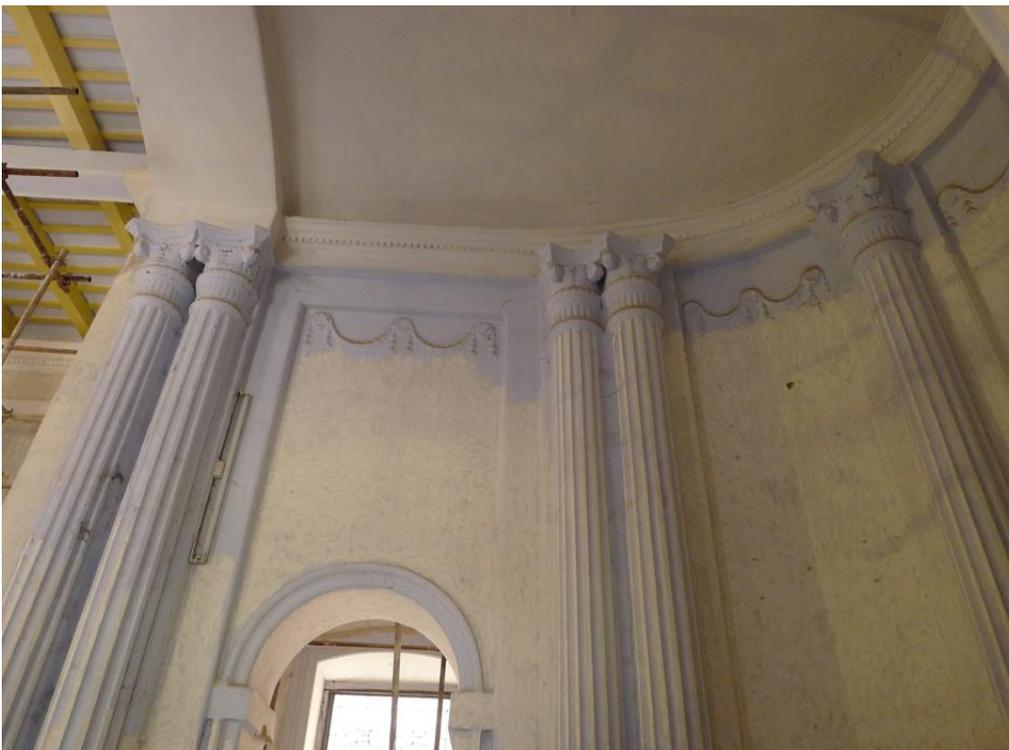
Fig . 5. View of the upper part and ceiling of the apse before change of colors and completion of the restoration. The Neo- classical interior decoration with the fluted half columns, Corinthian capitals, pilasters and stucco garlands, as well as a dental cornice and plastered ceiling with stucco décor, was designed by Armstrong in 1806 (cf. fig X). In conclusion of the paint research the architectural details will be accentuated in white against a pale blue color of the wall niches. Photo: Flemming Aalund.

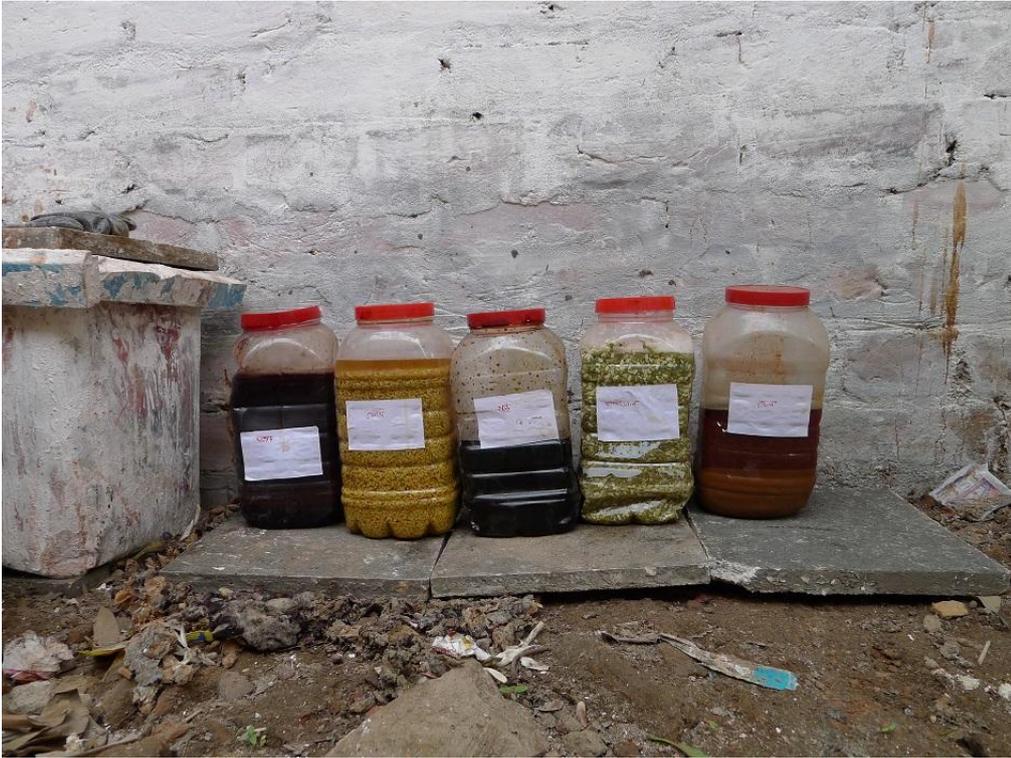
Fig. 12. Additives of Jaggery, Molasses, Yeast and other traditional admixtures ? More info required !

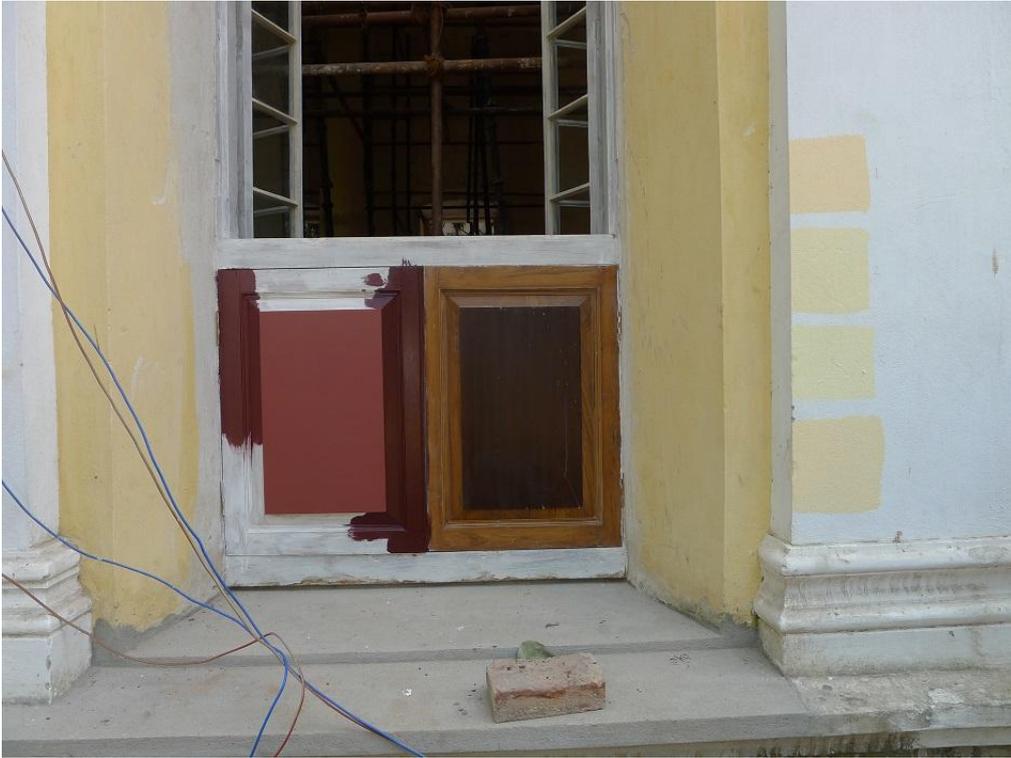
Fig. 20 Different external paint color samples of redish brown on wooden panels and ochre color wash of the facades in search of the single best hue of the final paint. Photo: Flemming Aalund

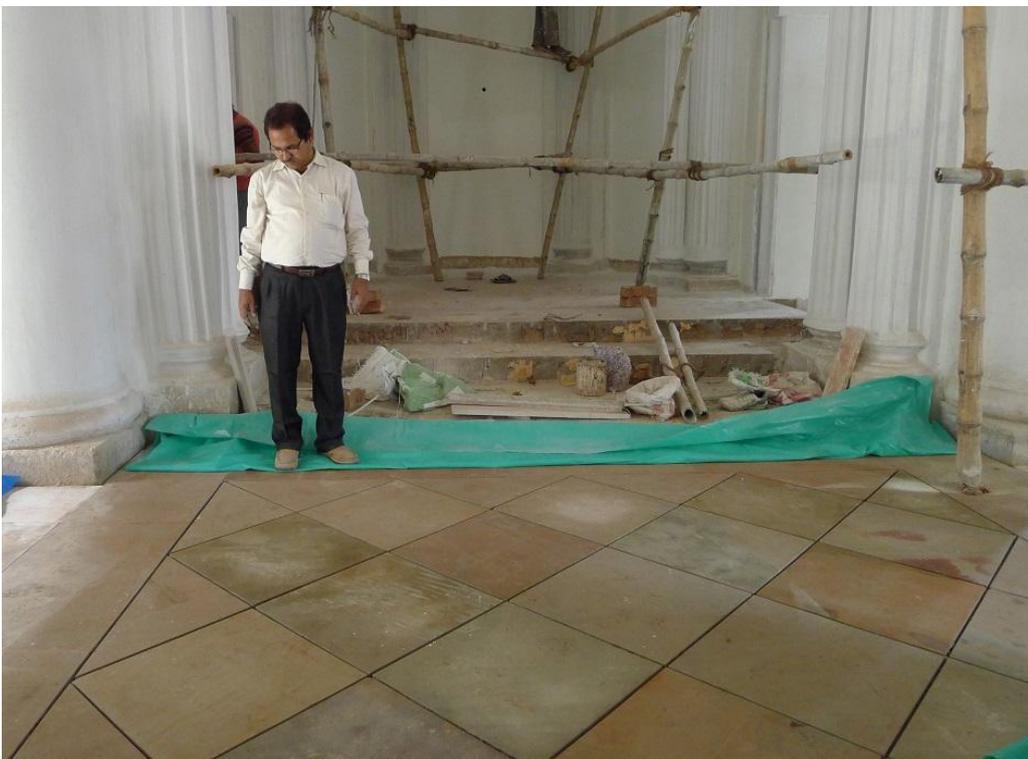
Fig. 21. The contractor, Mr Asherjee Muchadjee, is expecting the newly laid sandstone floor in the nave. Photo: Flemming Aalund.

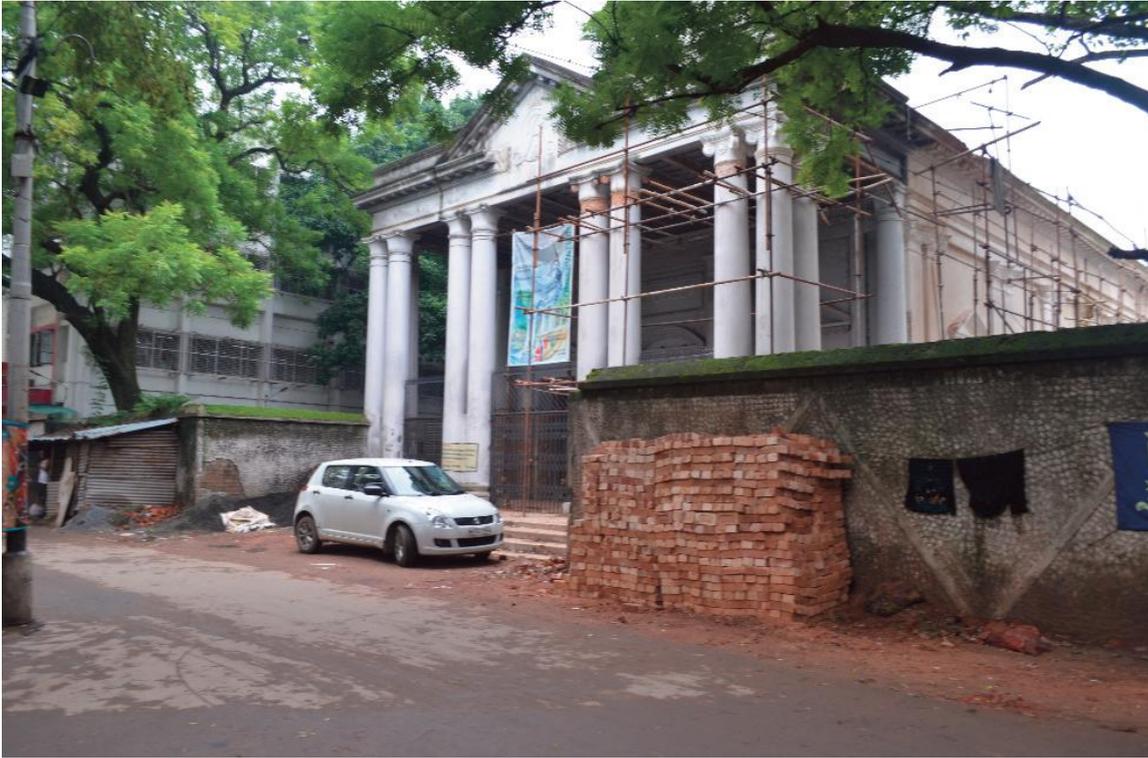
Fig. 24. Front of the church with the brick wall surrounding the church ground. Photo: Manish Chakraborti

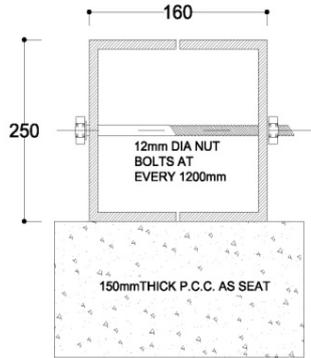
TYPE A : 2 Nos. ISMC Channel, Flange to Flange
250X160
d = 250, b = 80,

- NOTE:**
- a) The bottom level of all the beams should be same
 - b) The beam should be painted with epoxy primer like Fiazinc R of Sika or equivalent for protection against corrosion.
 - c) The beams should be wrapped with dense chicken wire mesh while placing the channels for tiles. It should be then plastered and chamfered at the edges at 45 degrees with a line on plaster to replicate the existing wooden beams.

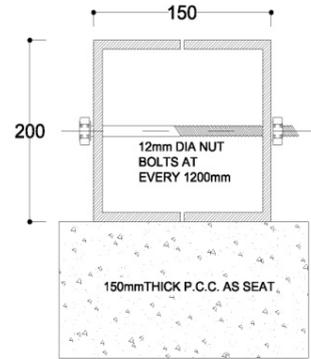
TYPE B : 2 Nos. ISMC Channel, Flange to Flange
200X150
d = 200, b = 75,

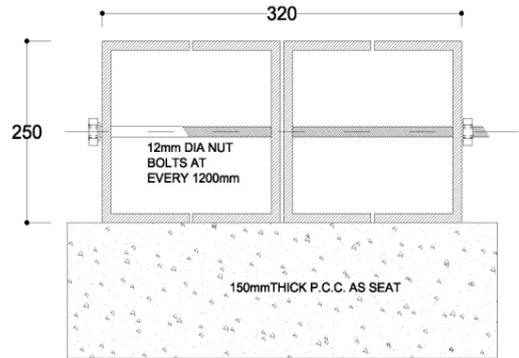
TYPE C : 4 Nos. ISMC Channel in 2Nos. box assembly
250 X 320
d = 250, b = 80,

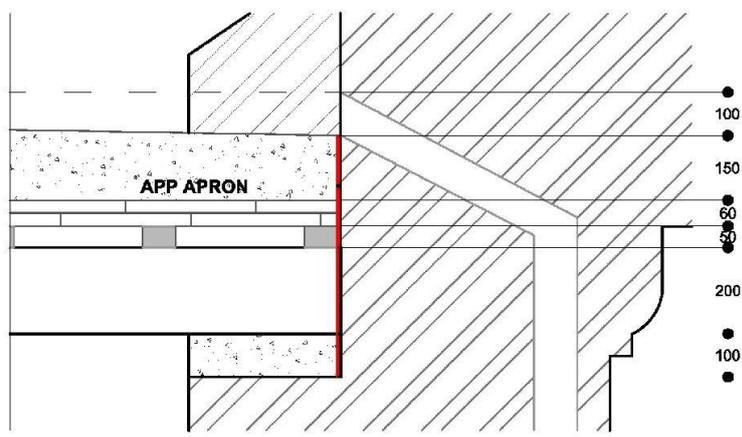
DETAIL AT B

Fig. 27. Drawing of roof construction, section and details A and B. Conservation architect Manish Chakraborti.
