UNESCO/UNEP PROJECT FOR CONSERVATION AND SUSTAINABLE DEVELOPMENT  
OF CULTURAL HERITAGE : URB/94/002/A/01

**Architectural conservation and restoration**

**Abd al-Aziz Khan Madrasa, Bukhara**

**Tillya-Kari Mosque and Madrasa, Samarkand**

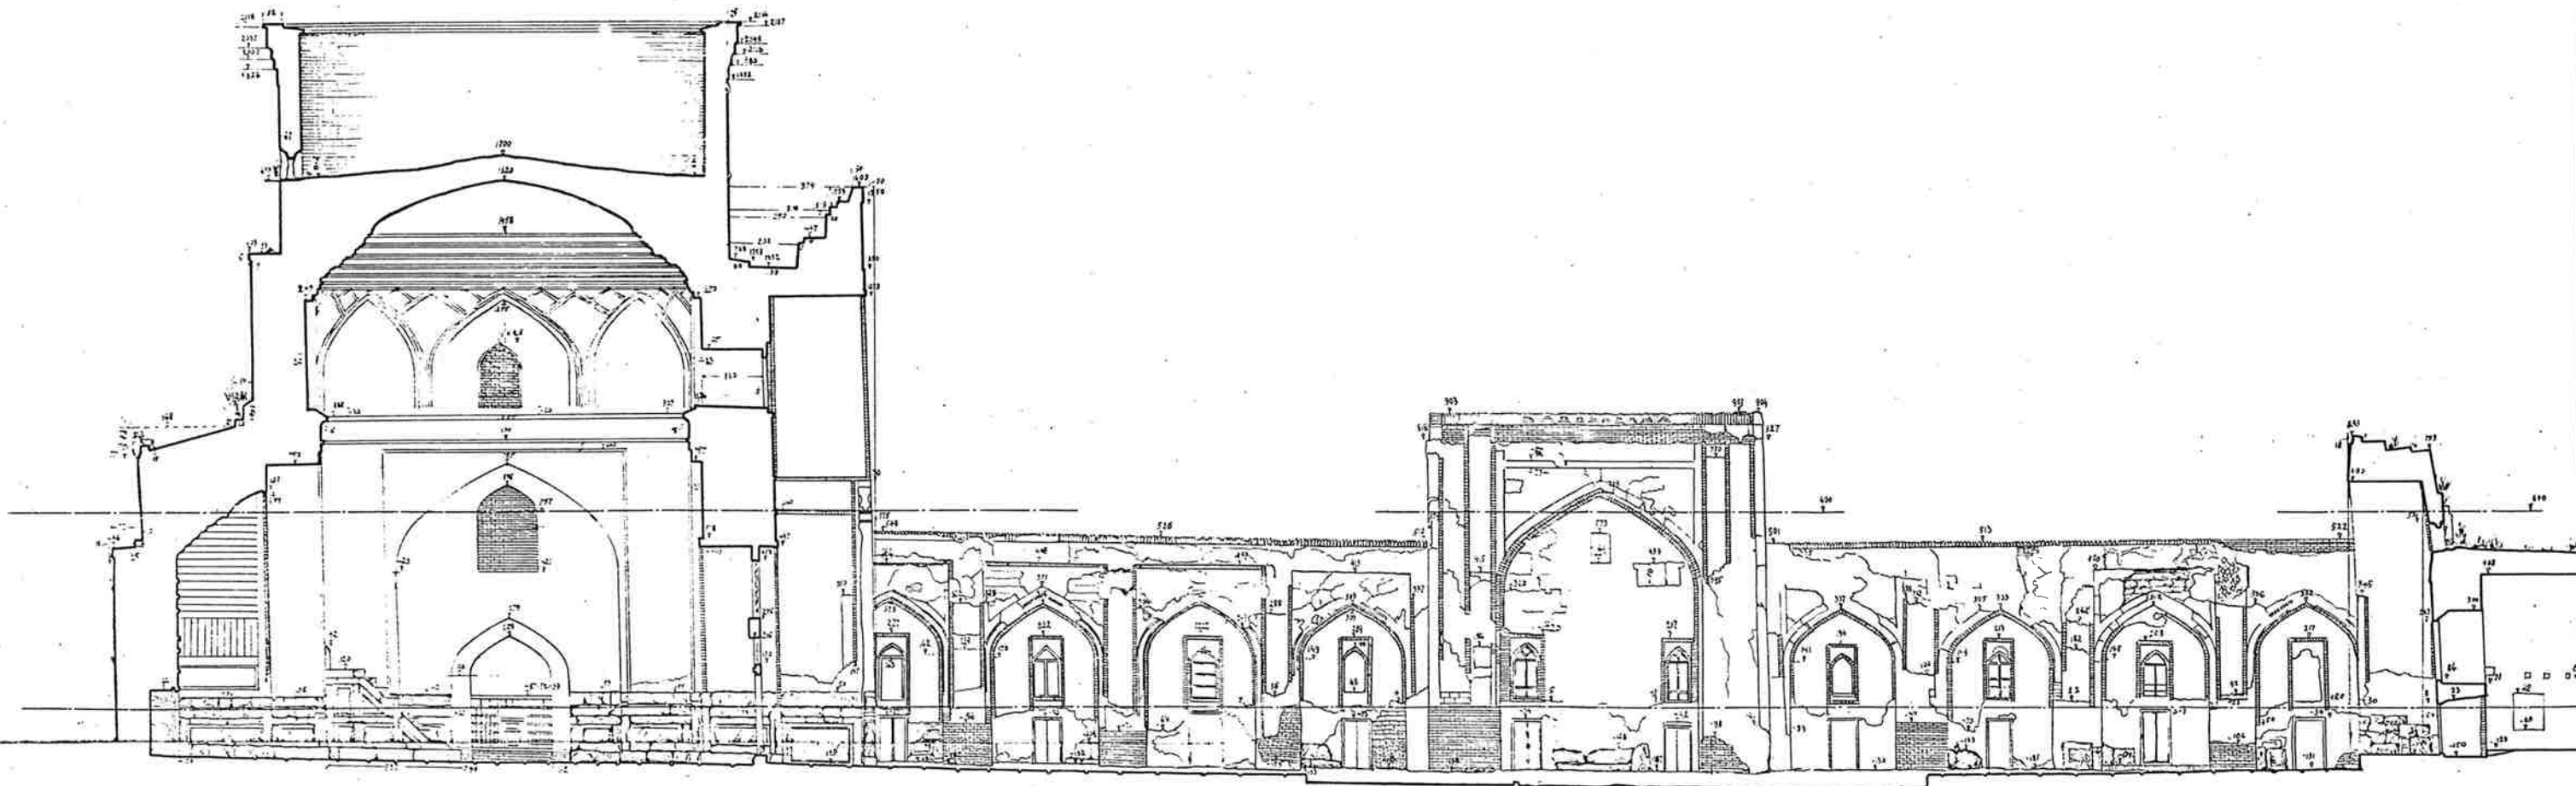
Main section West-East and section north-south, scale 1:200

Passes V-V

Passes V-VI
